Appendix C:
Geology and Field Characterisation

This appendix provides details of the site geology and subsurface investigations undertaken on behalf of the ITRB and other parties in the vicinity of the NTSF embankment failure.

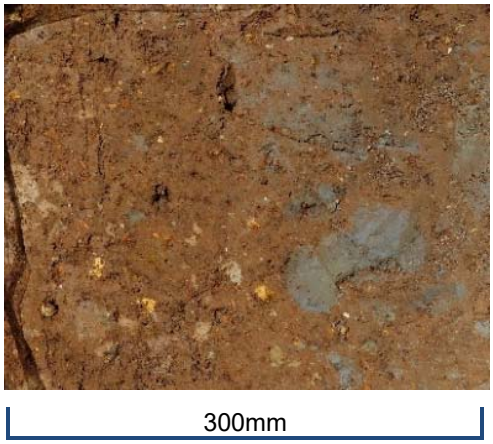
Figure C6-1: TP401 BL01 @ 1.0m

The residual basaltic soil typically graded into extremely weathered basalt. Figure C6-1 shows residual, red brown basaltic soil (high plasticity CLAY with some sand and gravel) with 50-100 mm diameter corestones of grey, extremely weathered basalt. A further 0.6 m below this sample, the basalt transitioned to highly weathered, then slightly weathered to fresh basalt a further 0.5 m below.

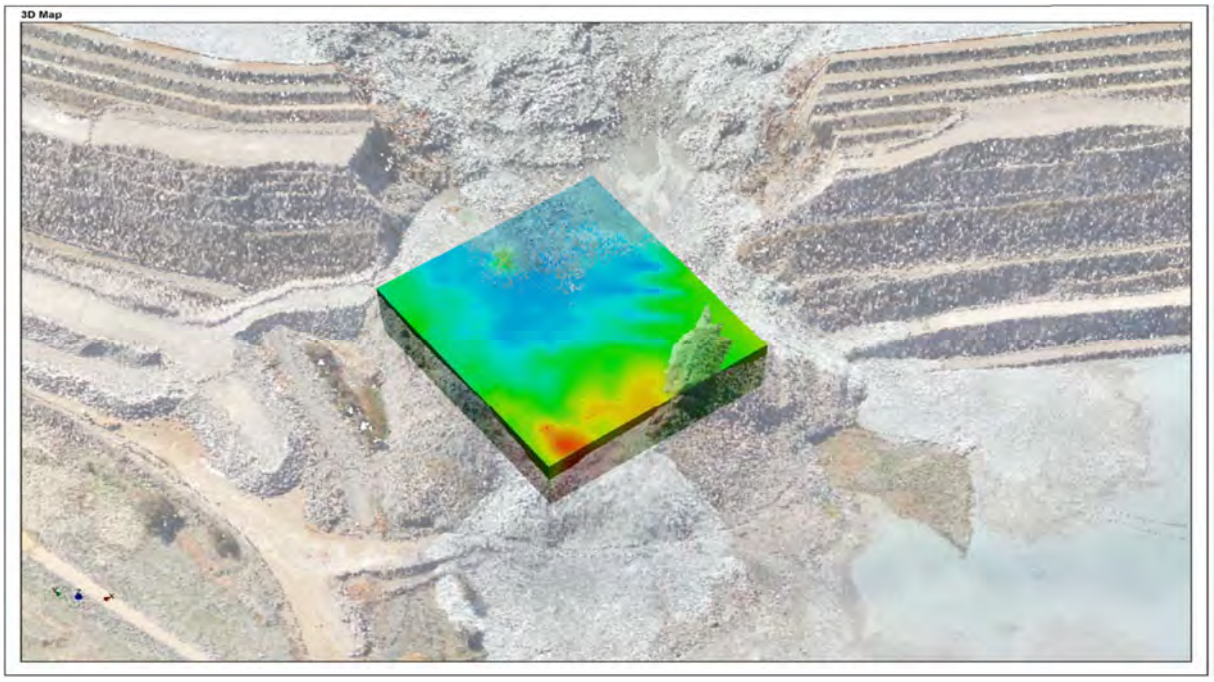
Figure 4-3 3D block model of apparent resistivity

The 3D block model created from the gridding of 2D ERI data is shown in Figure 4-3. It can be seen that the change in elevation over the survey area has resulted in the generation of blocks above the ground surface. The Clip to Surface utility was used to, as far as possible, remove model cells above the surface. The clipped 3D apparent resistivity model is shown in Figure 4-4.

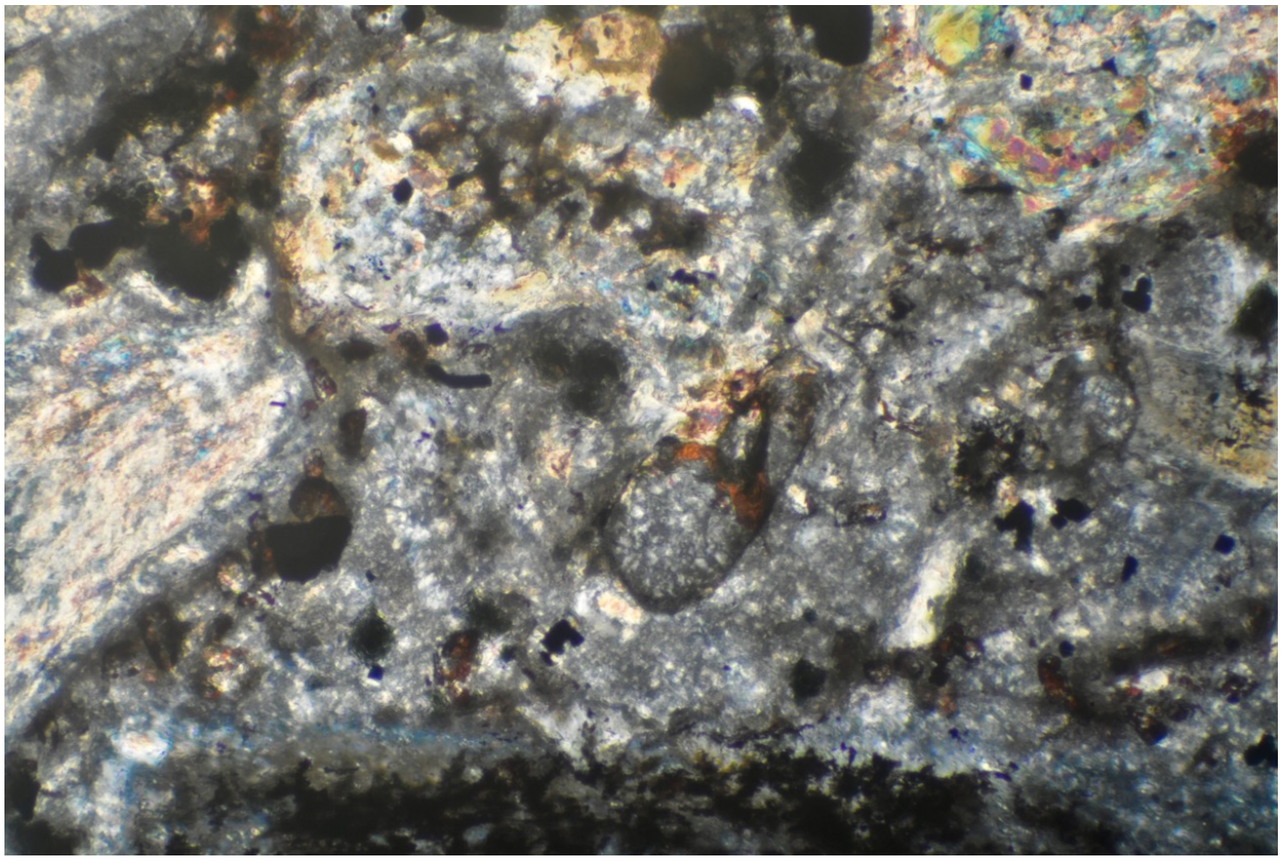
CE409-42.3m – w – same view as the previous photo in polarized light showing the speckled texture. Scale: side of photograph is 0.8mm

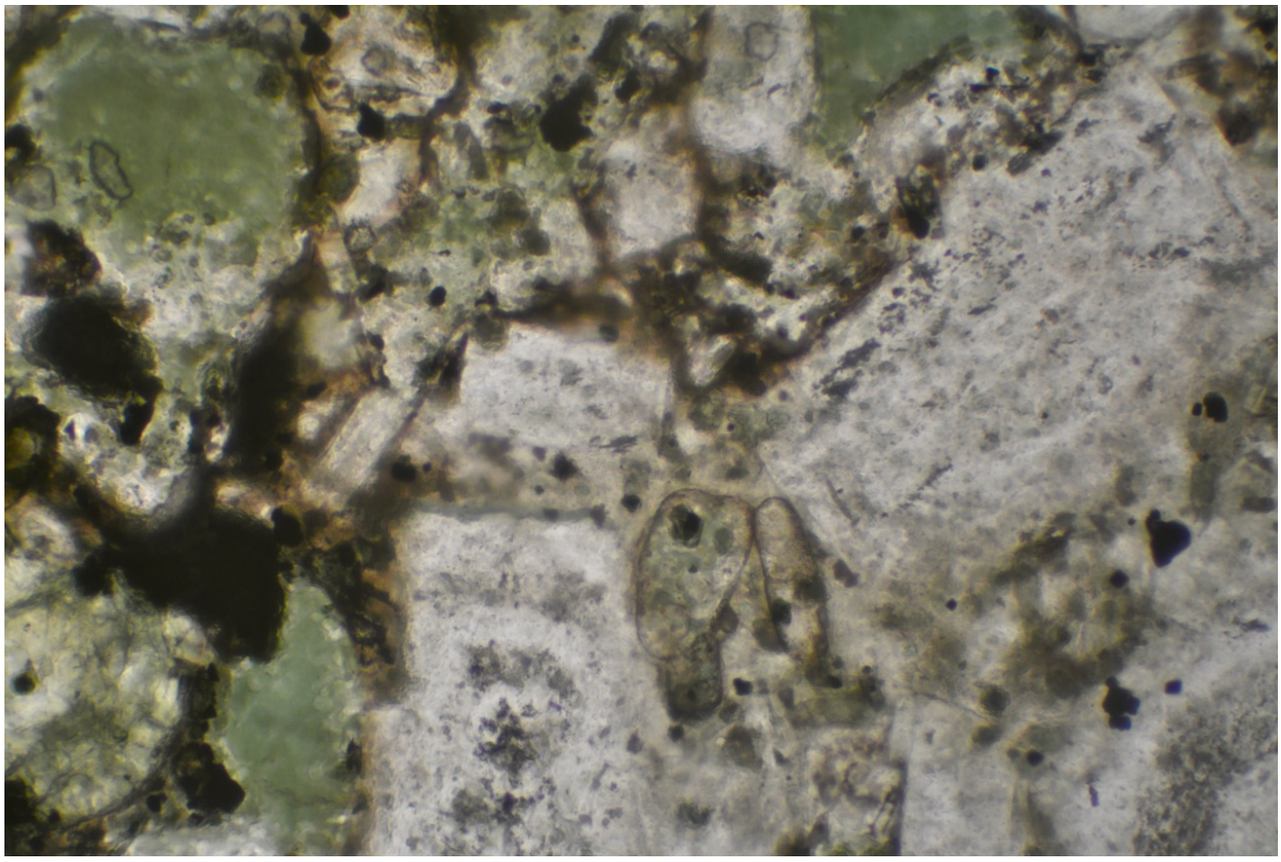
CE409-42.3m – x – another view of two rounded forms, the left with some chloritic alteration. Scale: side of photograph is 0.8mm

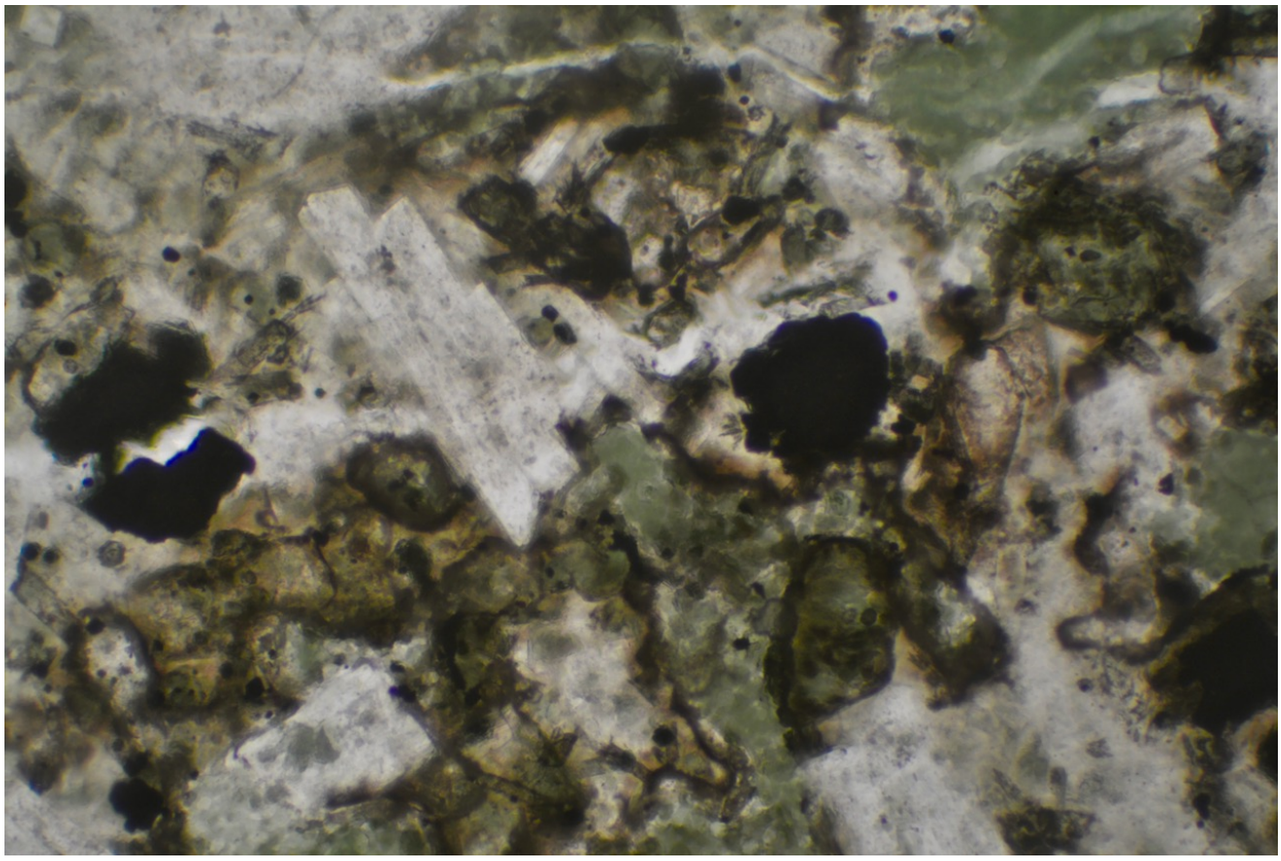
CE409-42.3m – y – another condenser-enhanced view of the typical groundmass, including several of the unidentified forms. Scale: side of photograph is 0.8mm

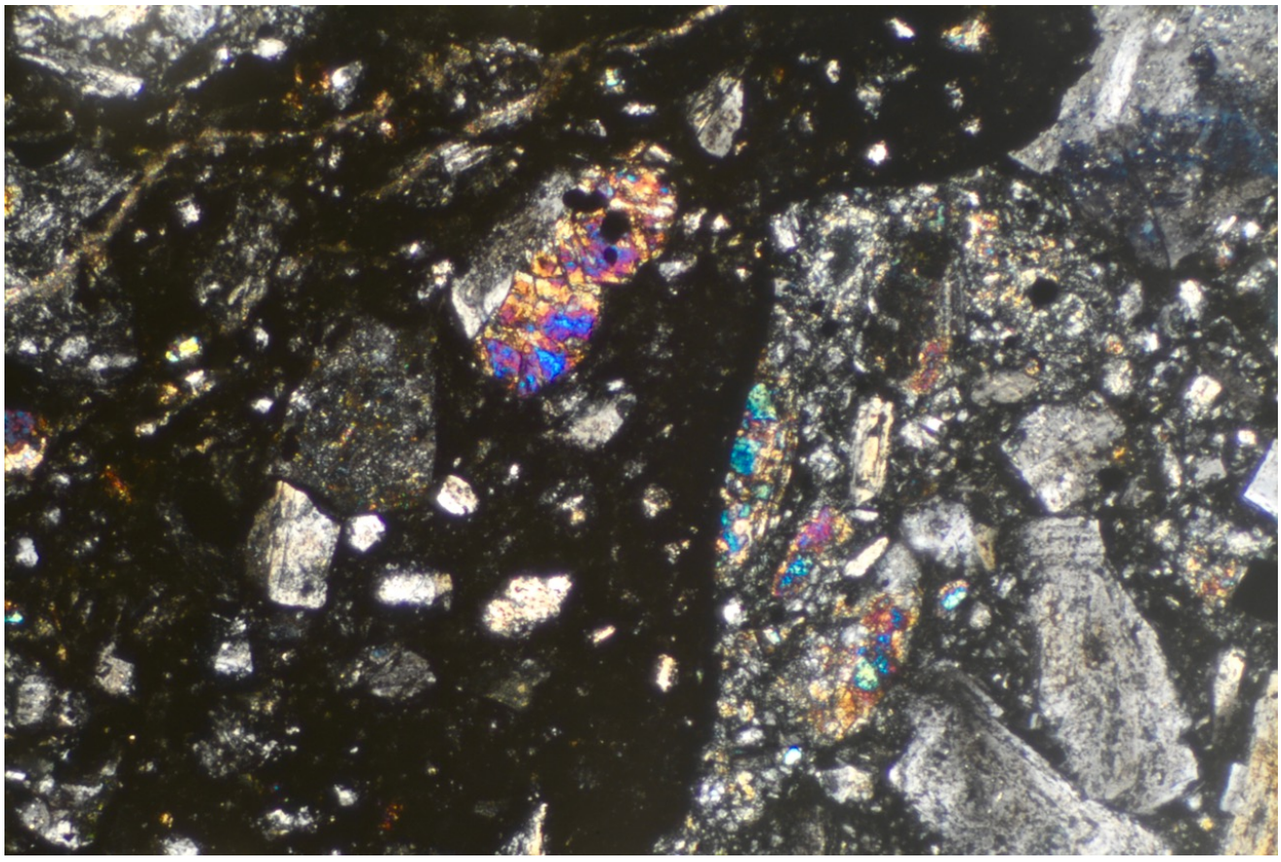
CE415-26.1m a - a common textural view in polarized light of this volcanic rock showing the contrast between the general groundmass and a large inclusion. Scale: side of photograph is 1.6mm

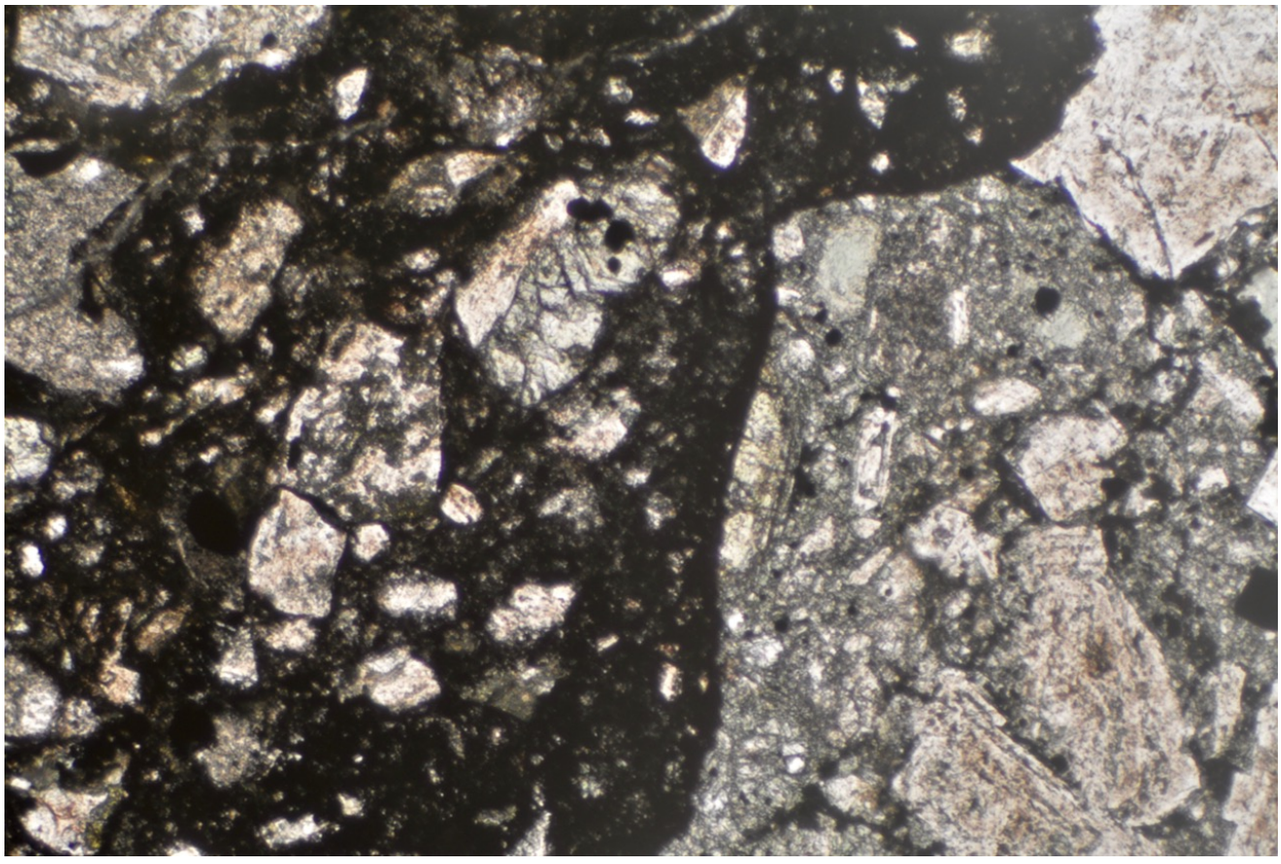
CE415-26.1m – b – same view as previous photo in ordinary light to better distinguish the dense dominant chlorite mineralogy of the groundmass. Scale: side of photograph is 1.6mm

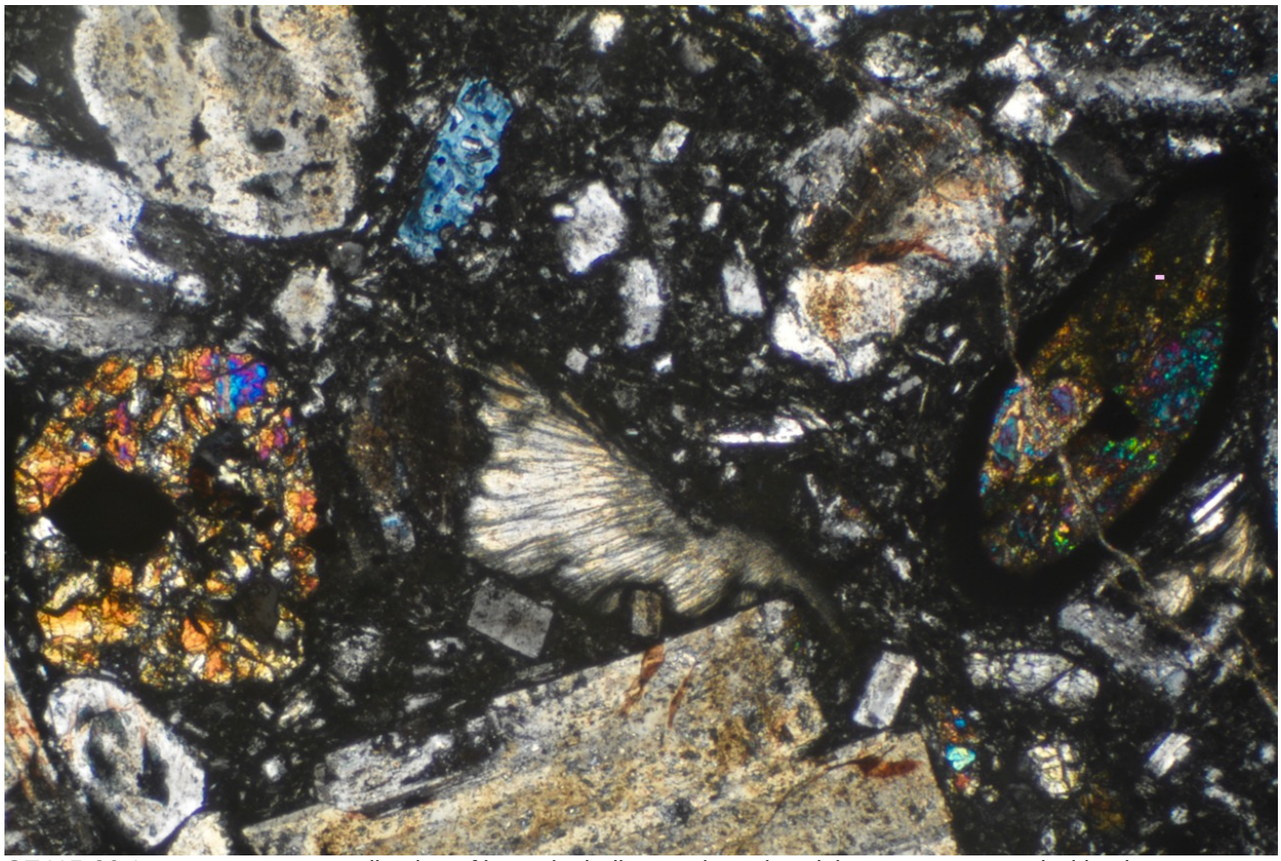
CE415-26.1m – c – a strange collection of items including a prismatic calcic pyroxene crystal with a large opaque mineral inclusion, a lens-shaped feature with a thick oxidation rim (right) but containing epidote, a radiating prehnite structure in the centre, a bluish chlorite patch and a thin calcitic veinlet. Scale: side of photograph is 1.6mm

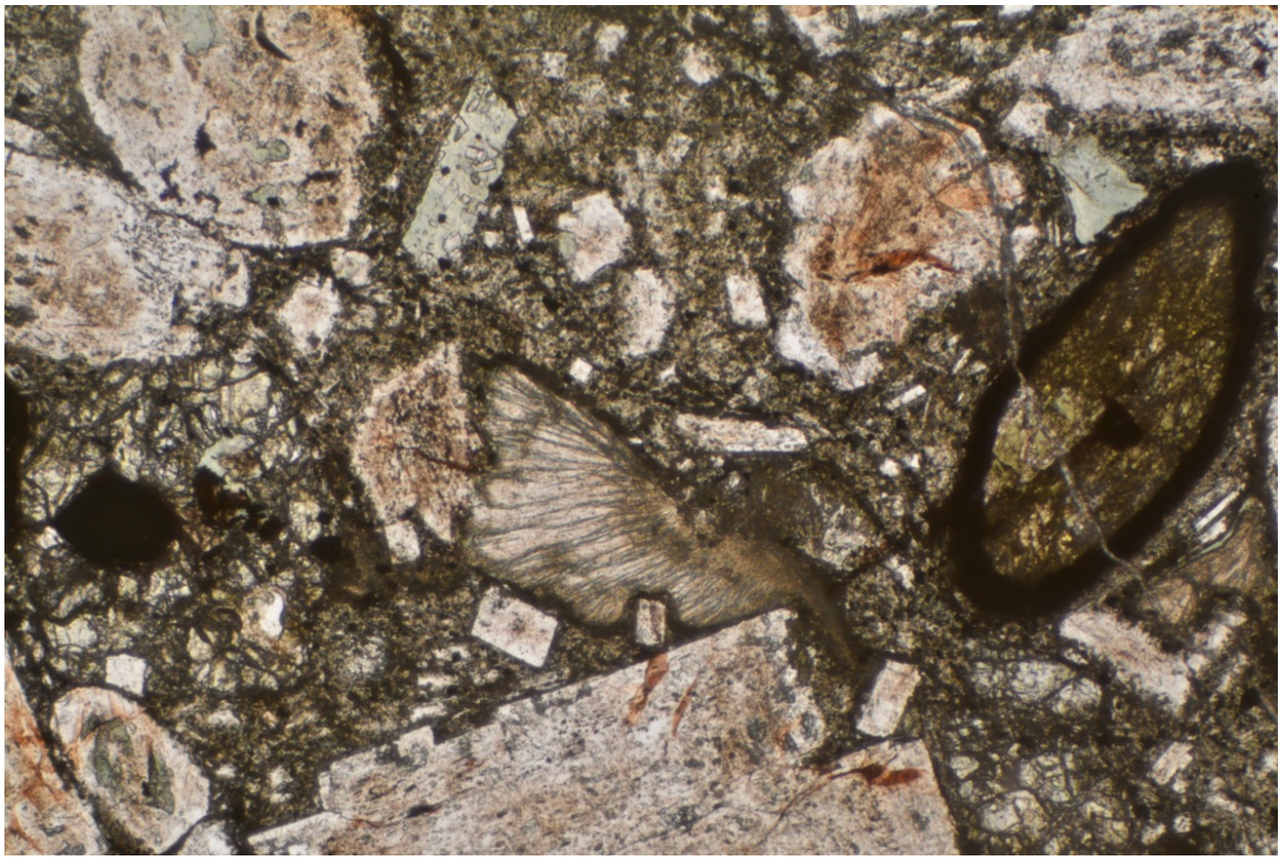
CE415-26.1m – d – same view as previous photo in ordinary light highlighting the discolouration of the plagioclase feldspar. Scale: side of photograph is 1.6mm

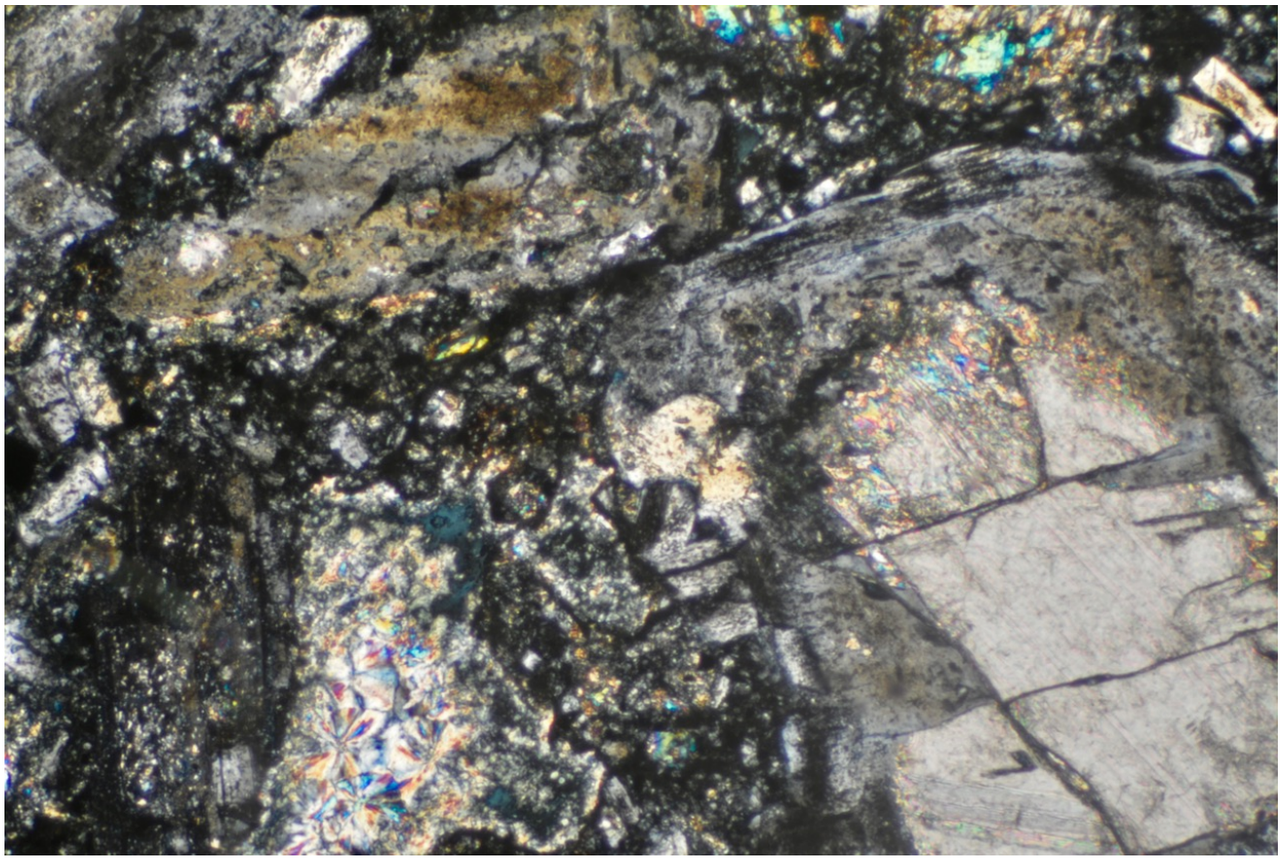
CE415-26.1m – e – a view of a large feldspar crystal that has been substantially replaced by calcite. Note also the patch of coloured sericite. Scale: side of photograph is 1.6mm

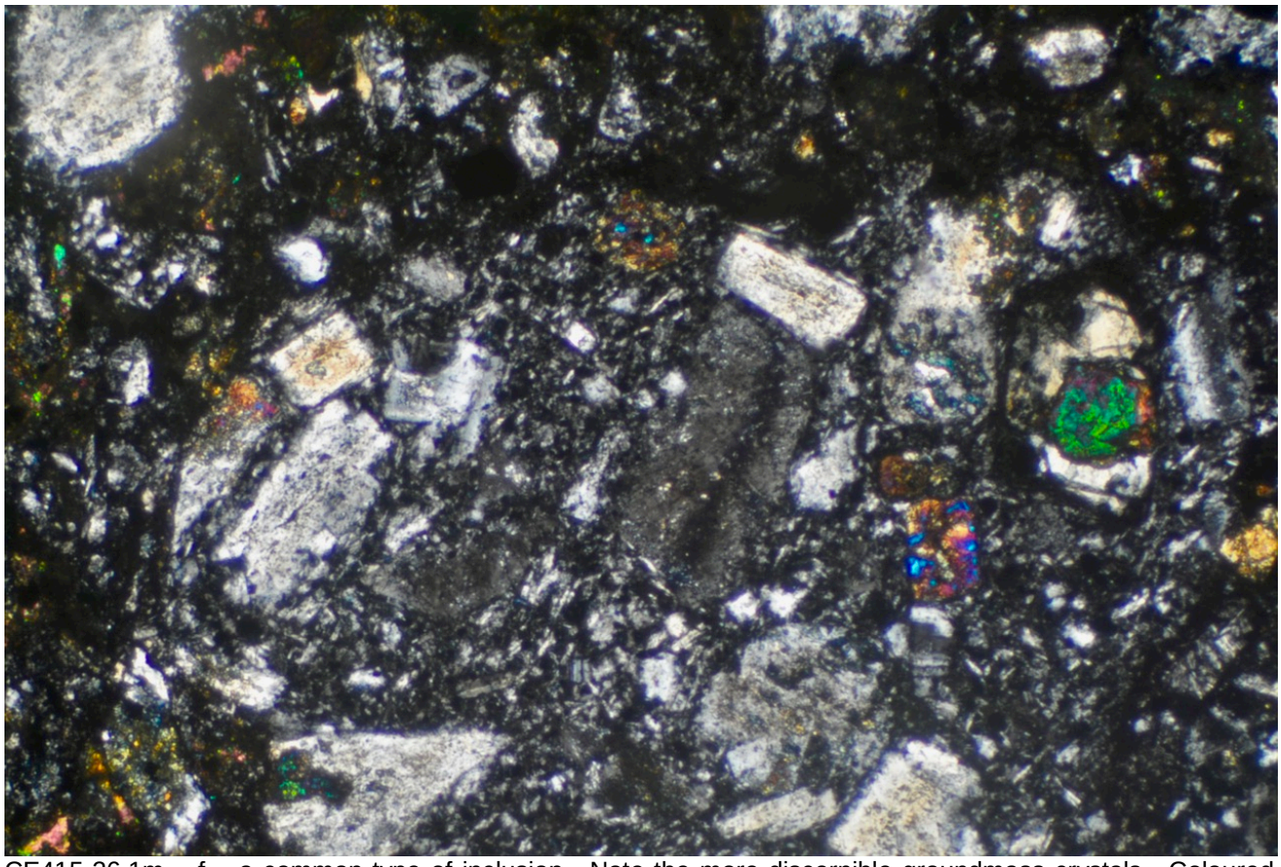
CE415-26.1m – f – a common type of inclusion. Note the more discernible groundmass crystals. Coloured crystals are epidote. Scale: side of photograph is 1.6mm

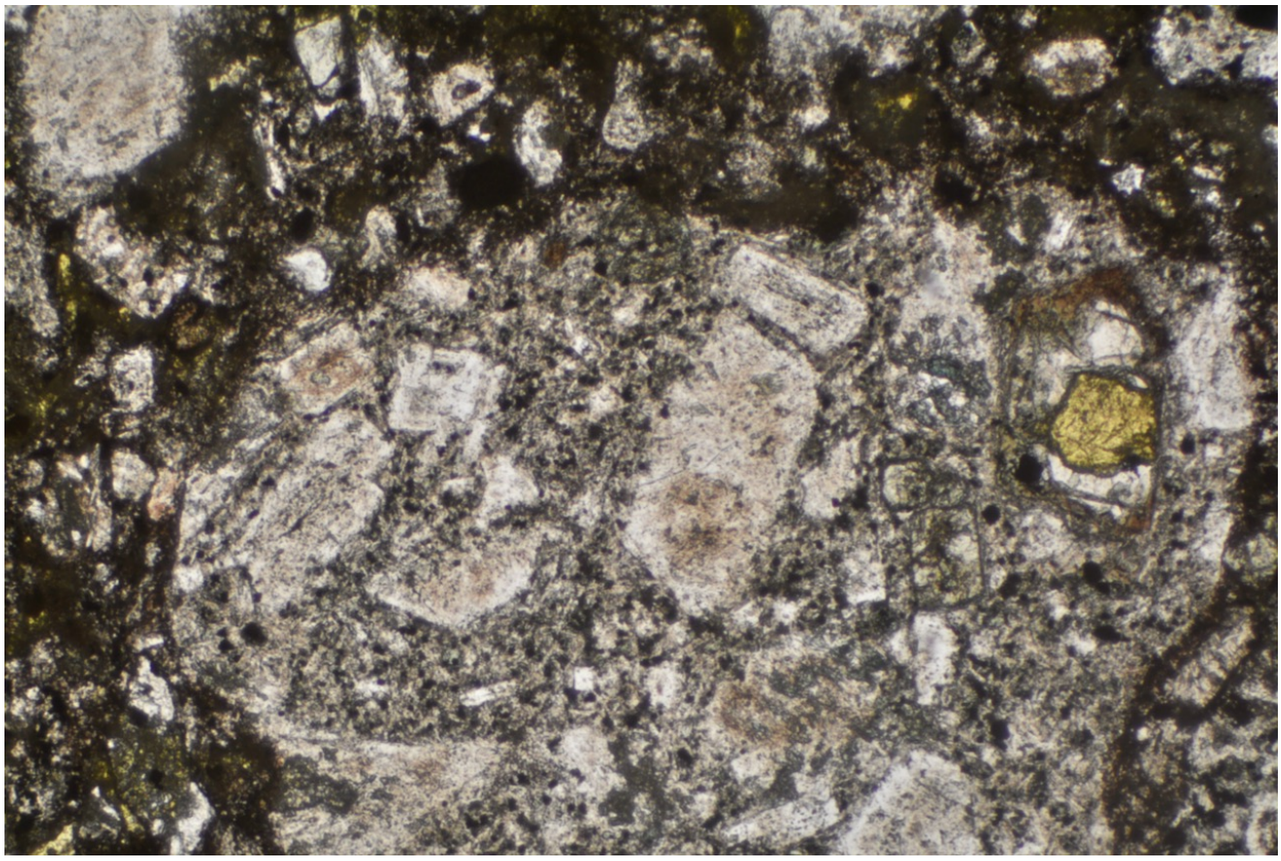
CE415-26.1m – g – same view as previous photo in ordinary light showing some feldspar colouration. Scale: side of photograph is 1.6mm

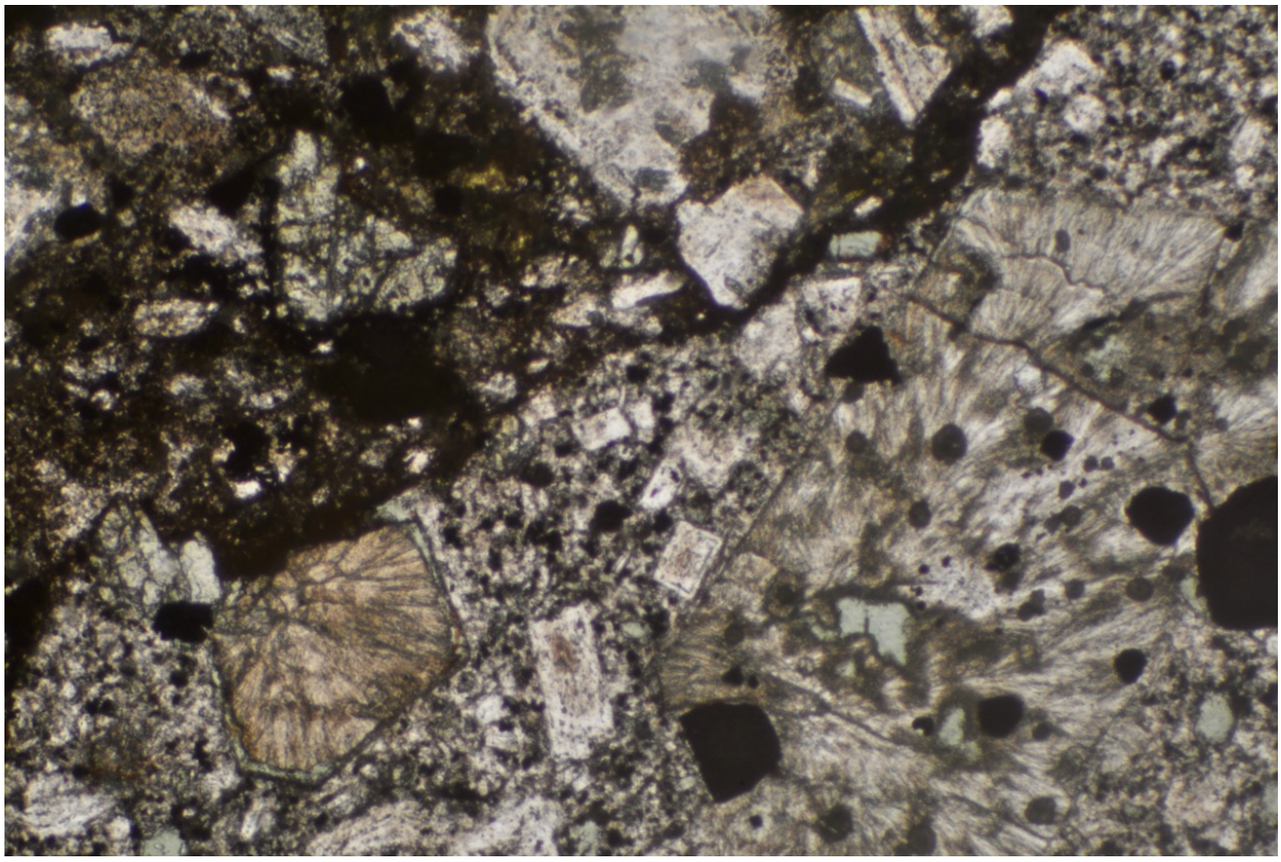
CE415-26.1m – h – portion of a large inclusion with prismatic feldspar and 3 patches of radiating prehnite. Scale: side of photograph is 1.6mm

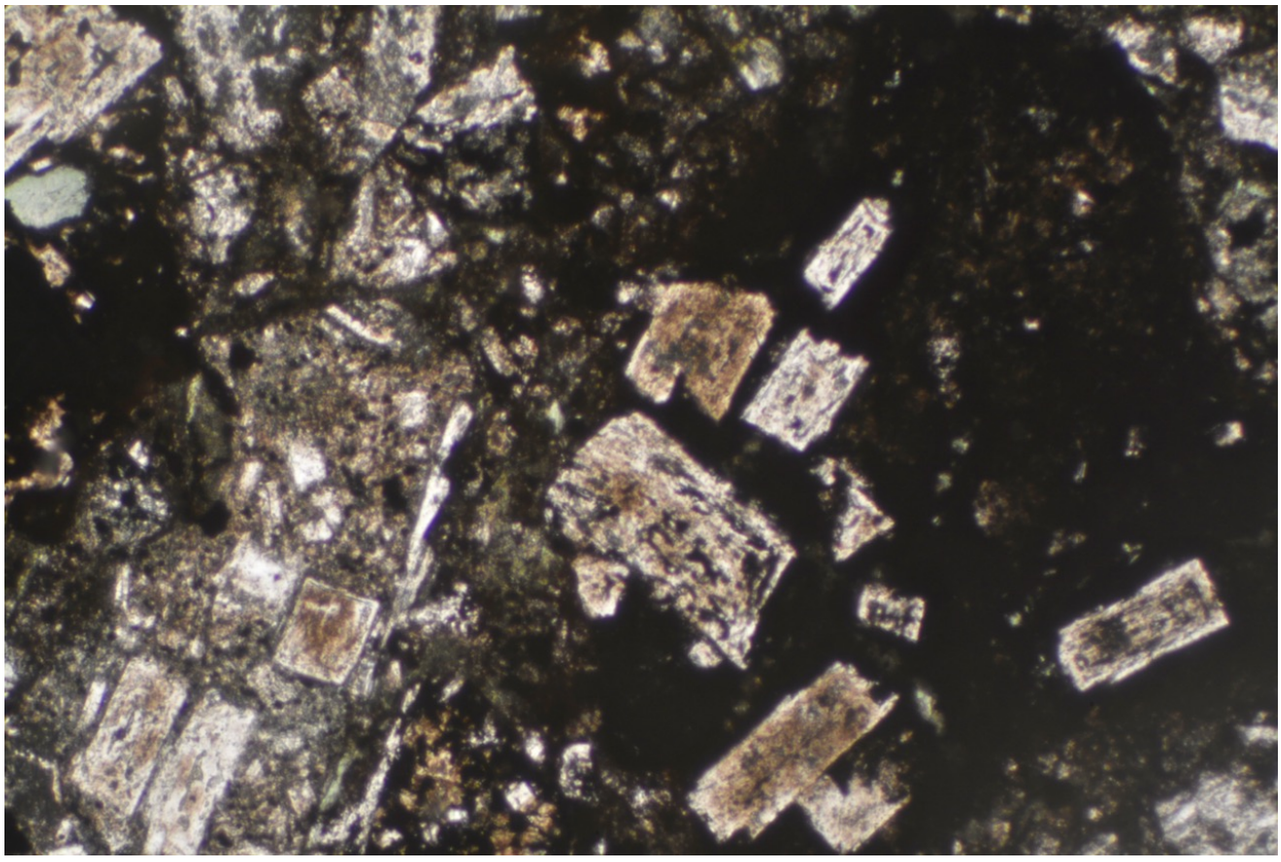
CE415-26.1m – i – two contrasting types of inclusion. Scale: side of photograph is 1.6mm

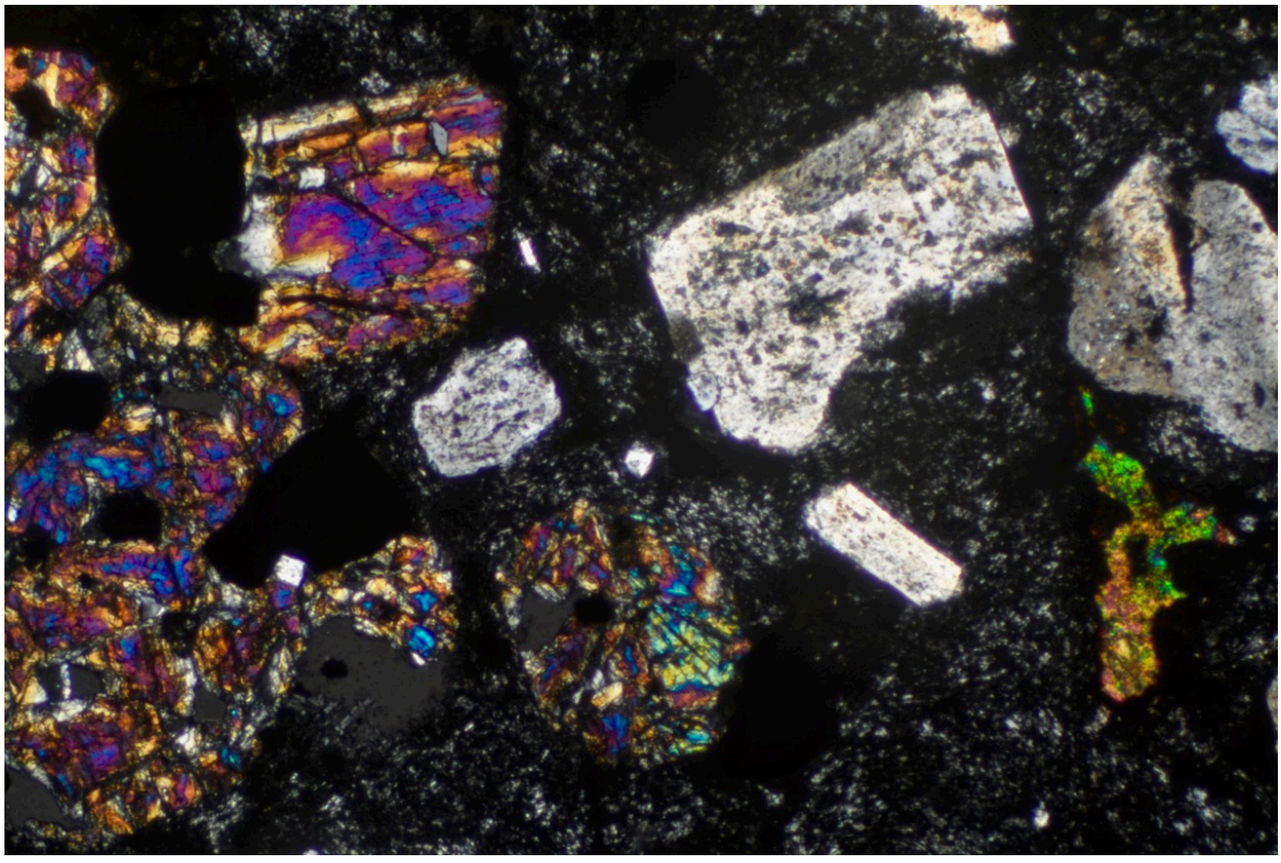
CE415-26.1m – j – another type of inclusion in which there are fresh-looking pyroxene crystals. The groundmass is extremely fine-grained. The greenish crystal to the right is epidote. Scale: side of photograph is 1.6mm

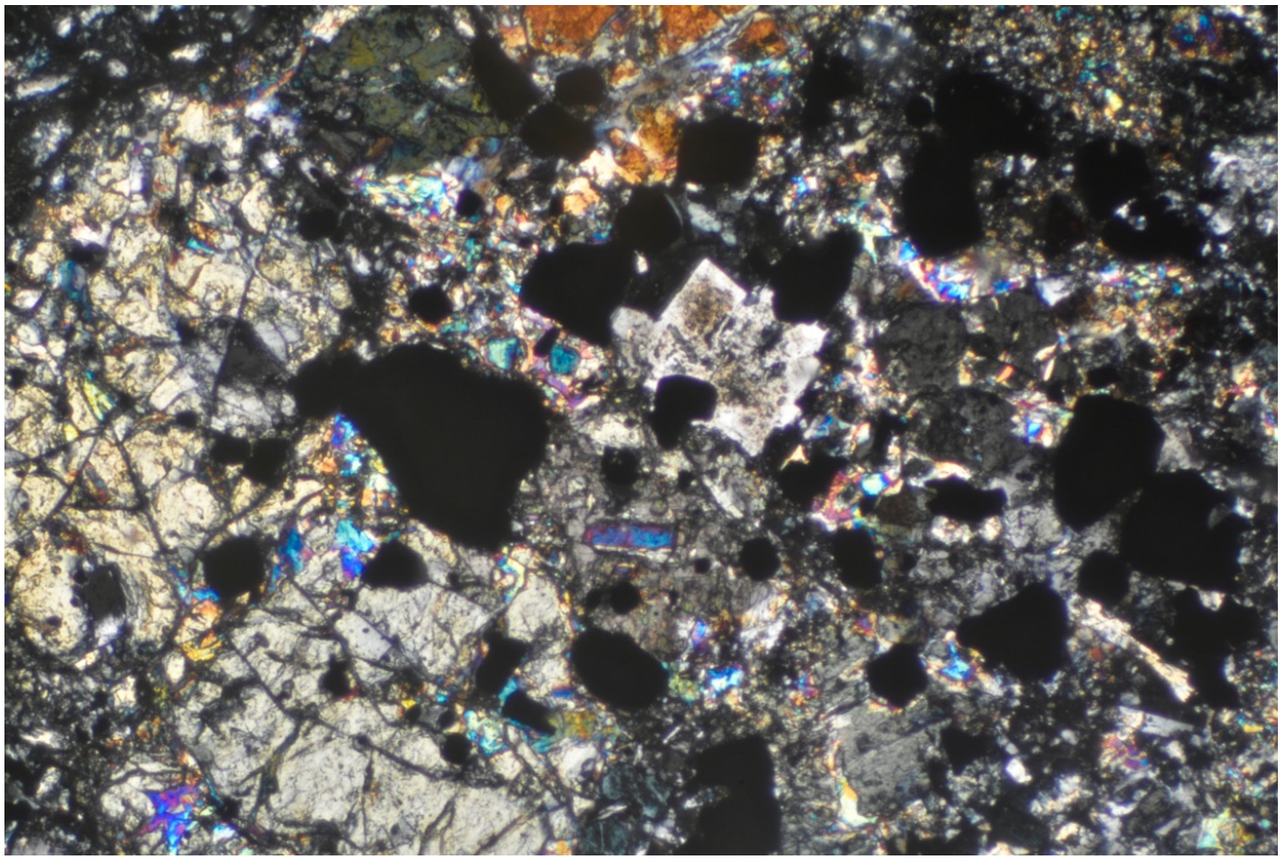
CE415-26.1m – k – a large calcic pyroxene crystal hosting numerous opaque oxide crystals. Scale: side of photograph is 1.6mm

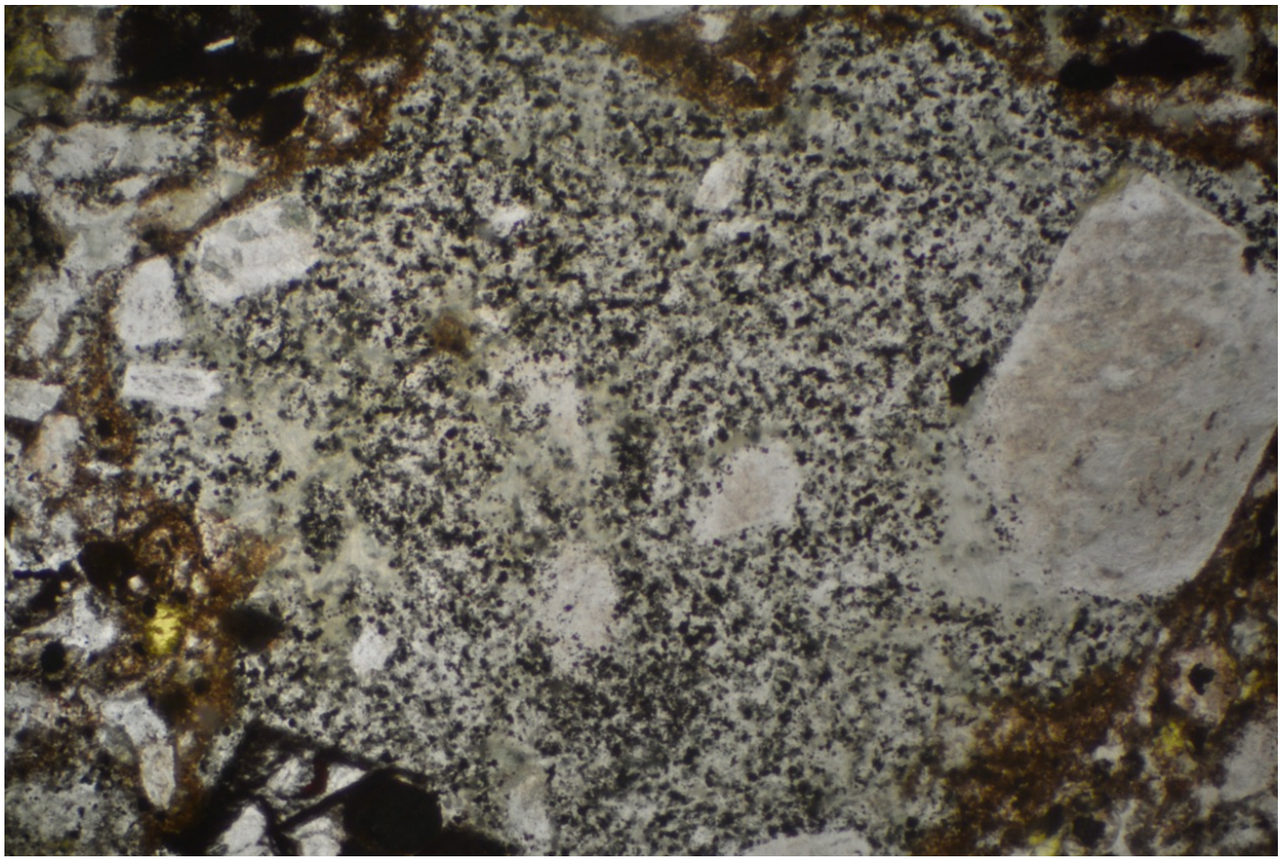
CE415-26.1m – L – another type of inclusion where the feldspar of the groundmass has been almost entirely replaced by chlorite. Scale: side of photograph is 1.6mm

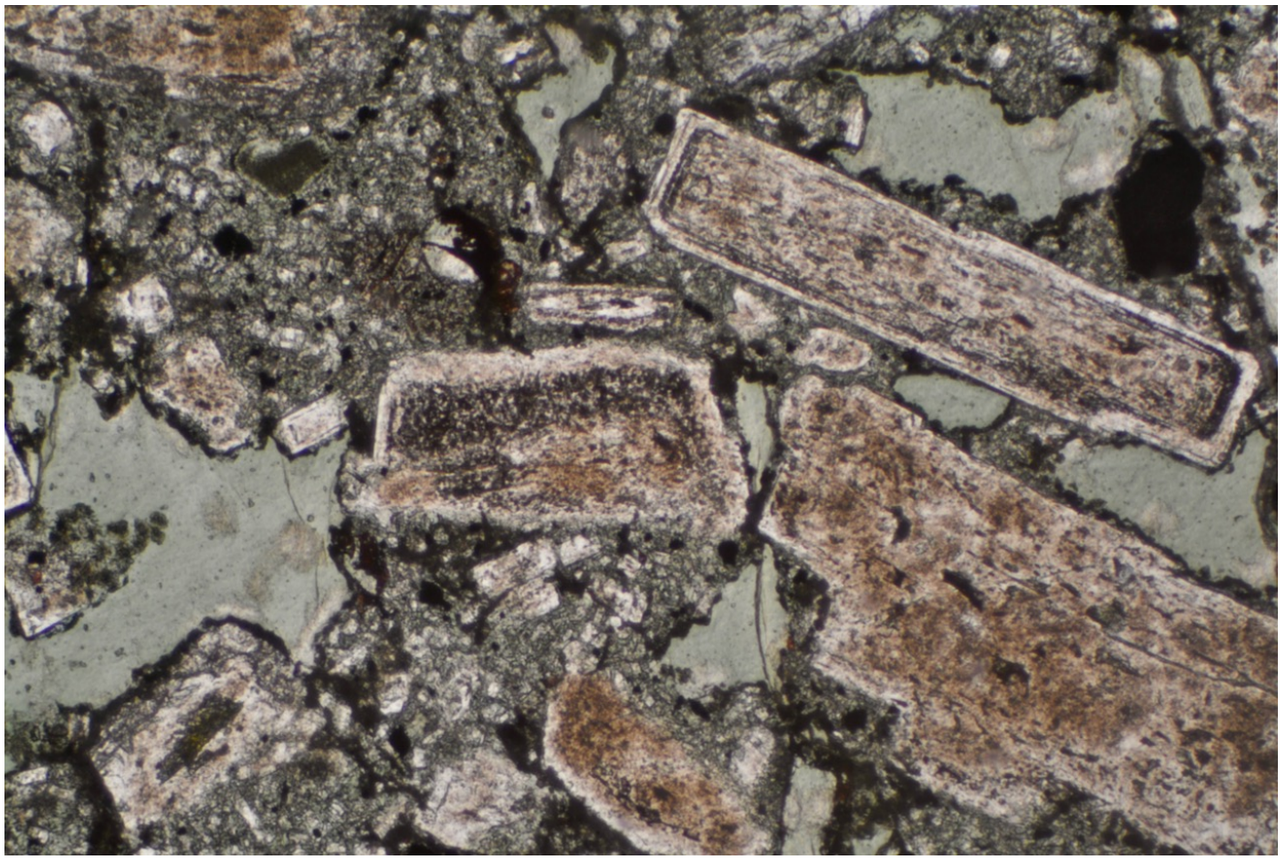
CE415-26.1m – n – another type of inclusion containing prismatic, compositionally zoned and reddened feldspar accompanied by numerous irregular patches of chlorite. Scale: side of photograph is 1.6mm

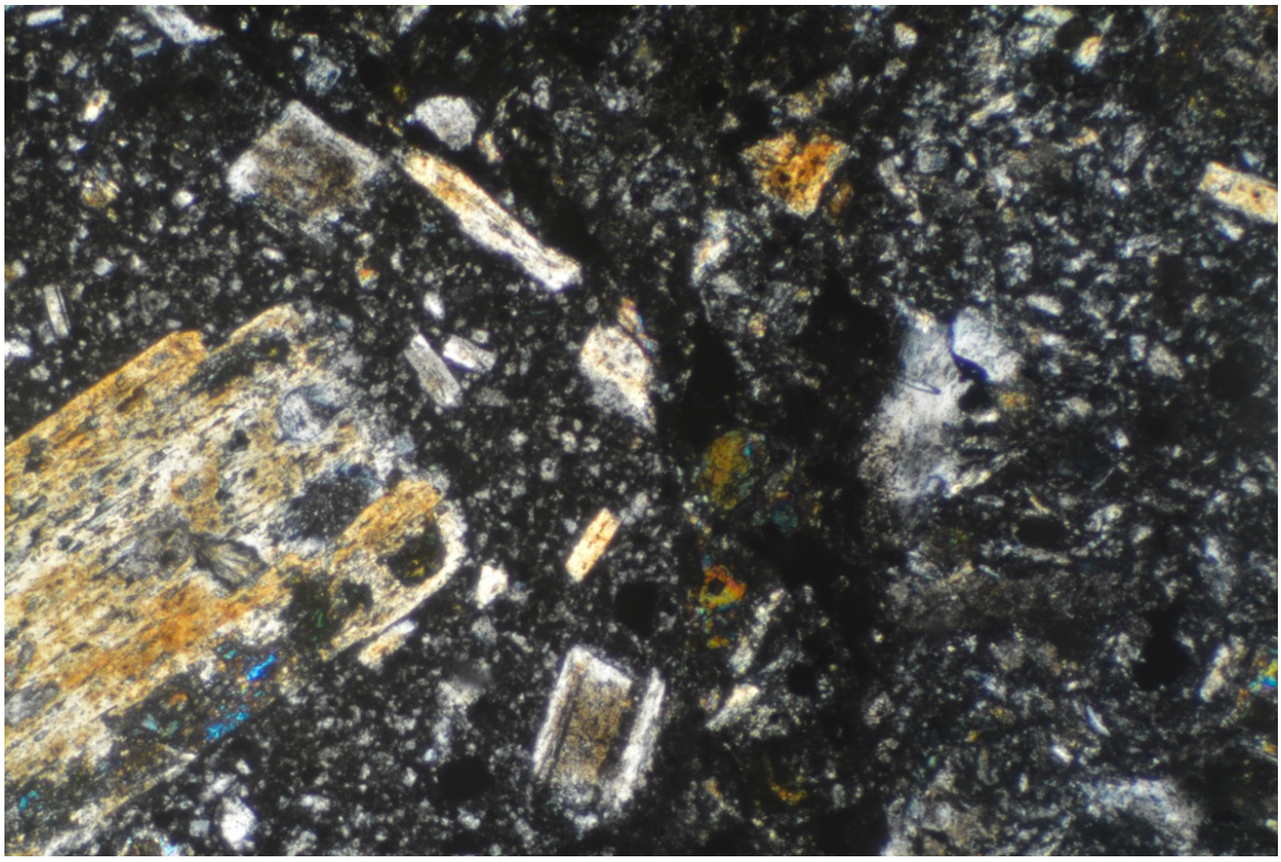
CE415-26.1m – o – two slightly different inclusions of chemically intermediate volcanic rocks. Scale: side of photograph is 1.6mm

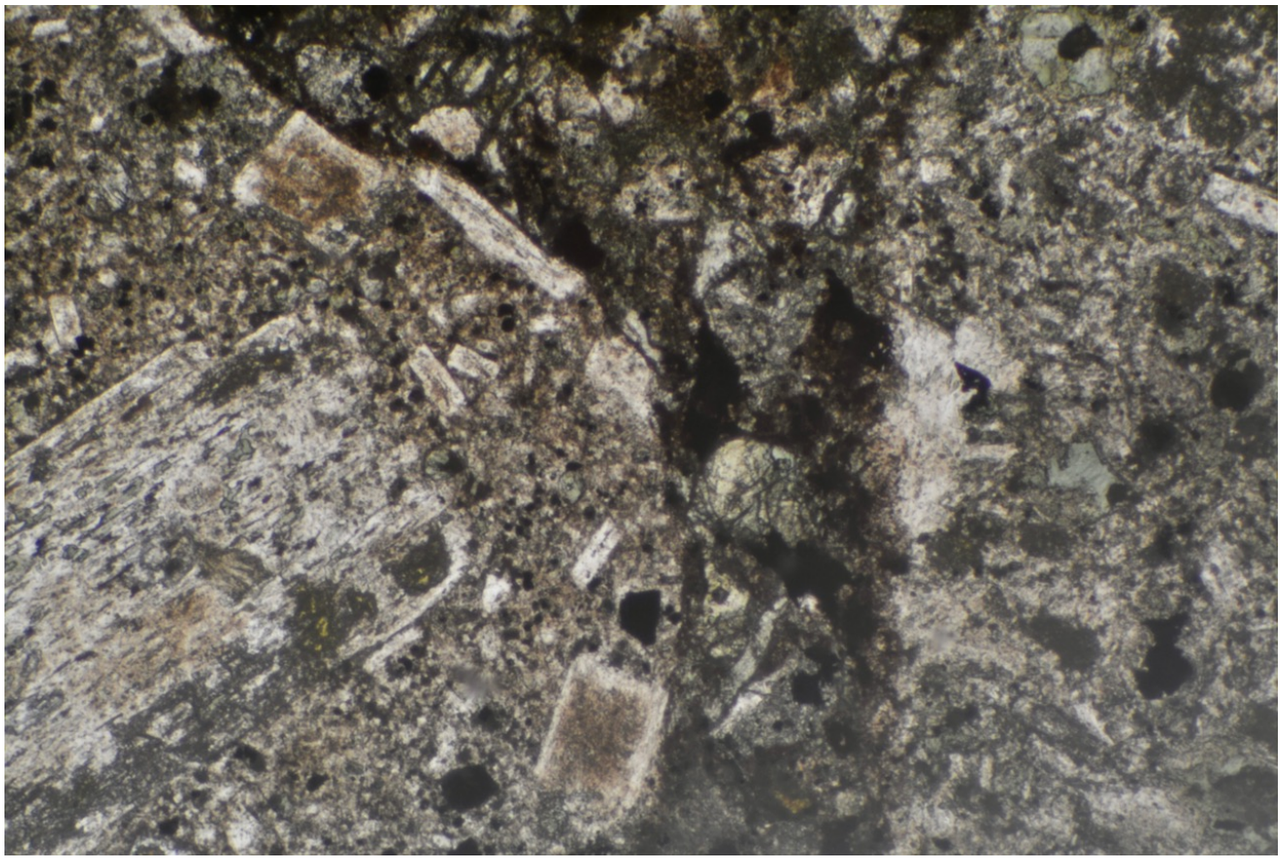
CE415-26.1m – o – same view as previous photo in ordinary light to better distinguish the mineralogy. The inclusion on the left has large feldspar phenocrysts and little chlorite whereas the inclusion on the right has no large phenocrysts but has abundant chlorite. Scale: side of photograph is 1.6mm

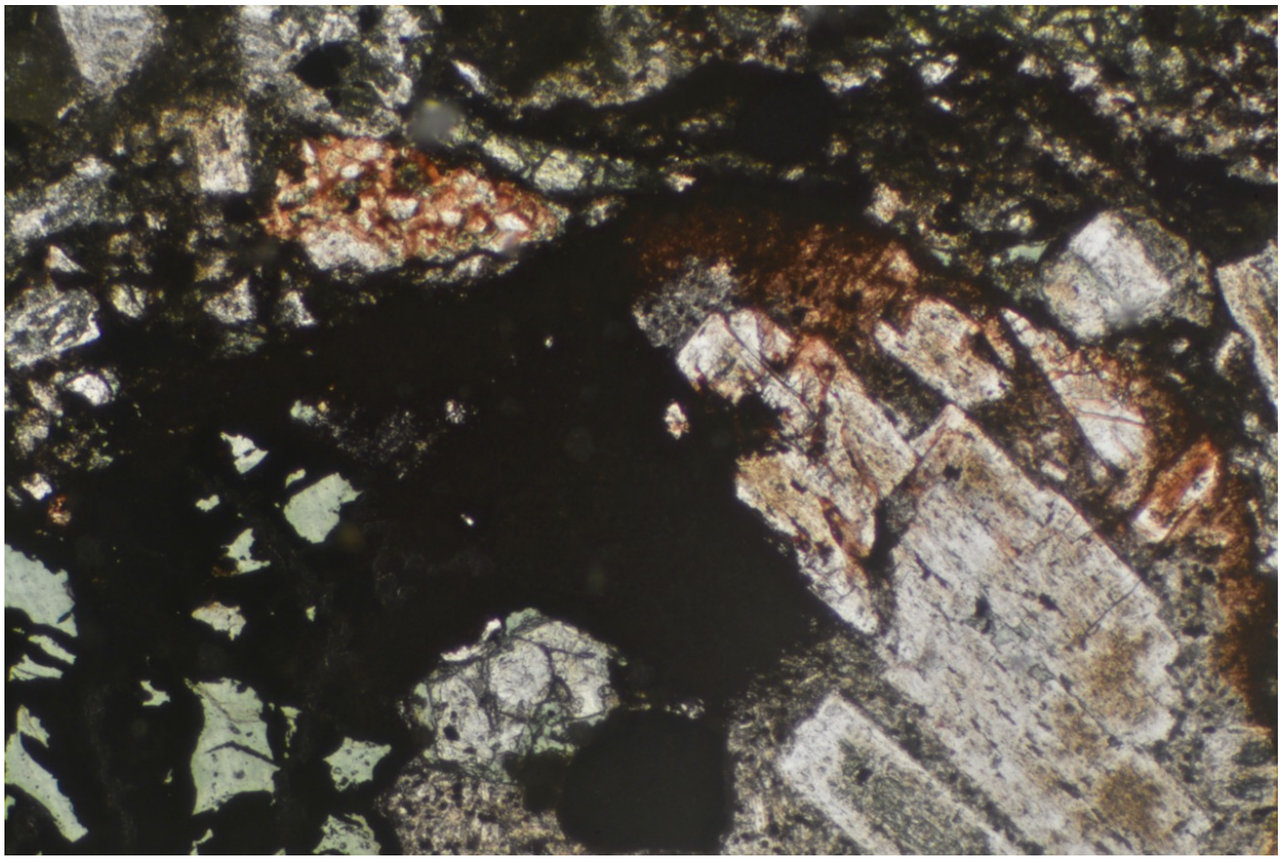
CE415-26.1m – o – a composite inclusion featuring a large patch of opaque material with associated chlorite as well as discoloured feldspar. Scale: side of photograph is 1.6mm
