Appendix C:
Geology and Field Characterisation

This appendix provides details of the site geology and subsurface investigations undertaken on behalf of the ITRB and other parties in the vicinity of the NTSF embankment failure.

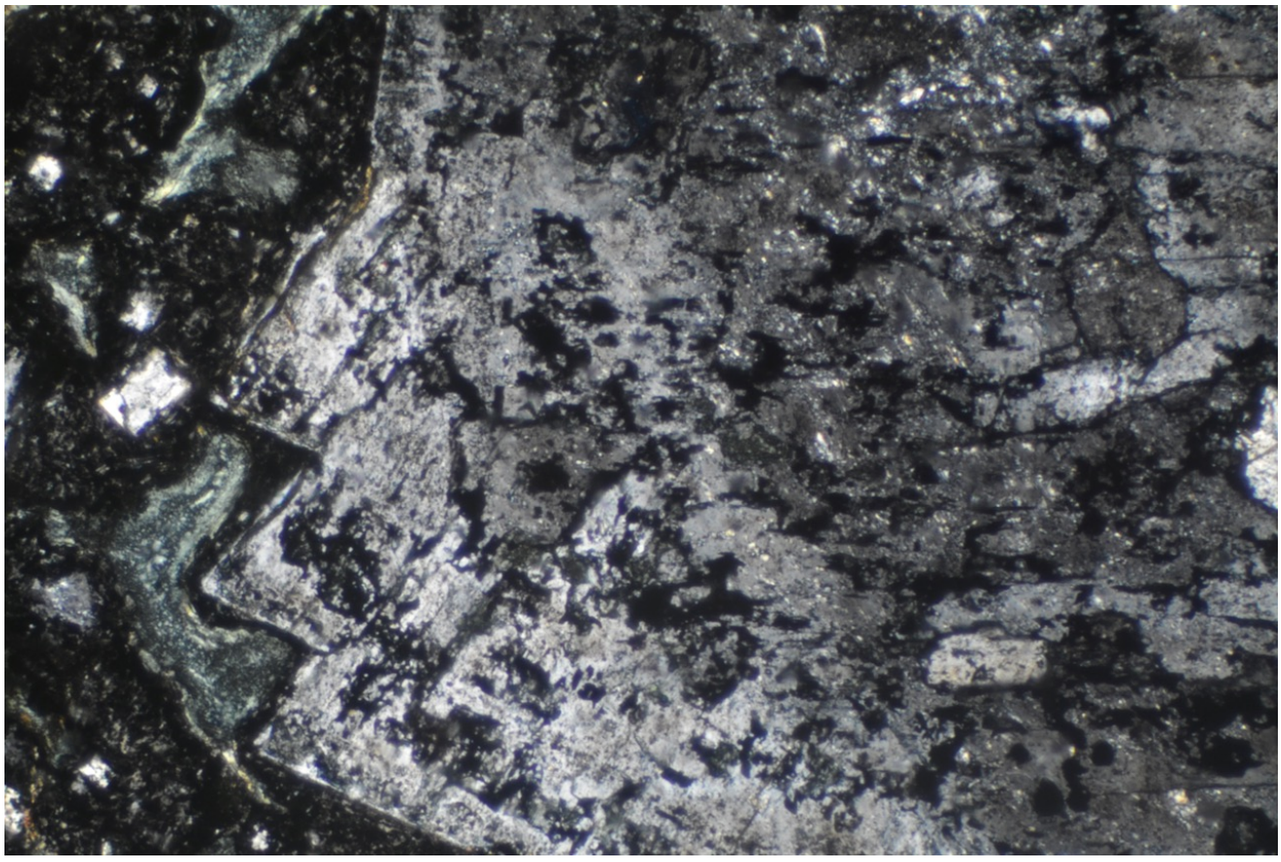
CE416-38.8m a - a common textural view in polarized light of this felsic volcanic rock showing some deformation textures of feldspar phenocrysts. The line of contrast through the centre is due to undulose extinction. Note the abundance of small opaque minerals. Scale: side of photograph is 1.6mm

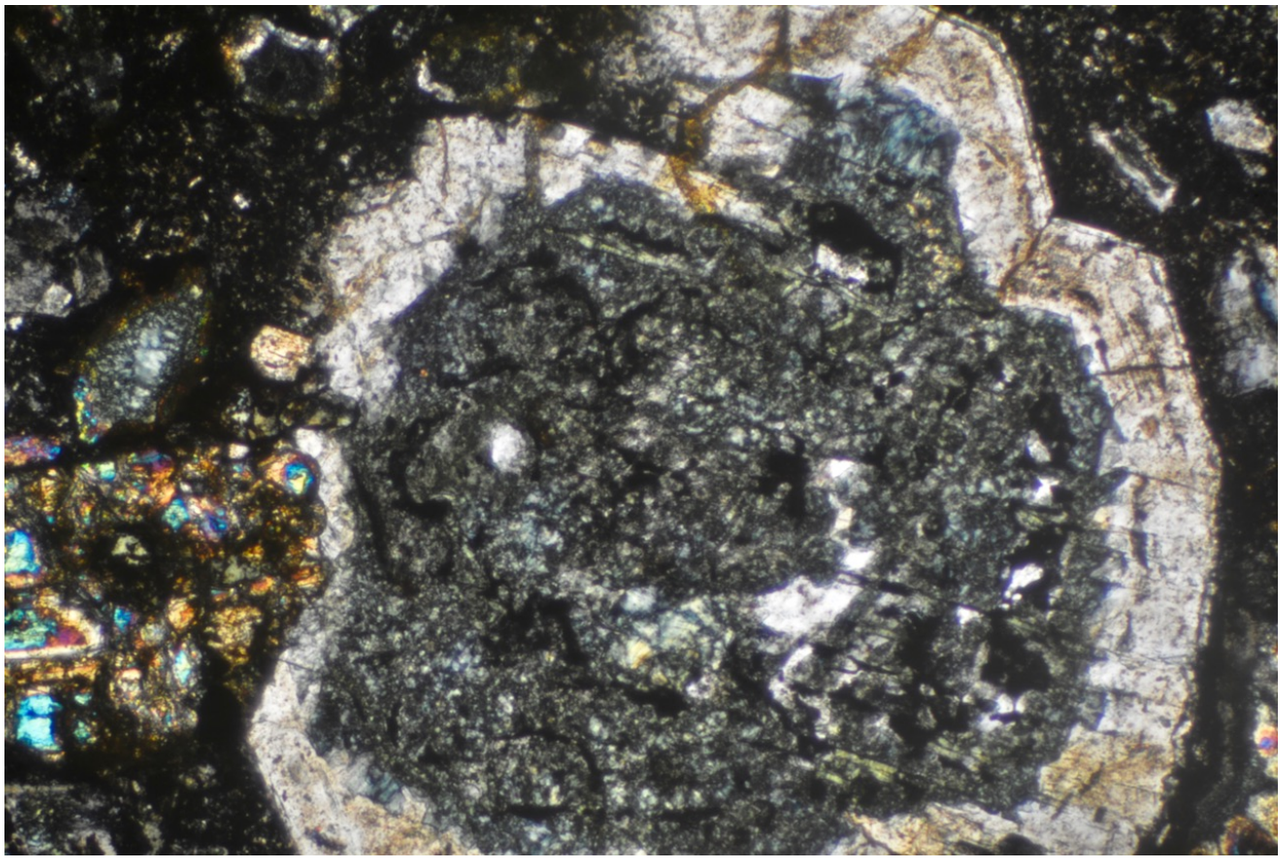
CE416-38.8m – b – another feldspar showing a thick rim and a chloritized core. Scale: side of photograph is 1.6mm

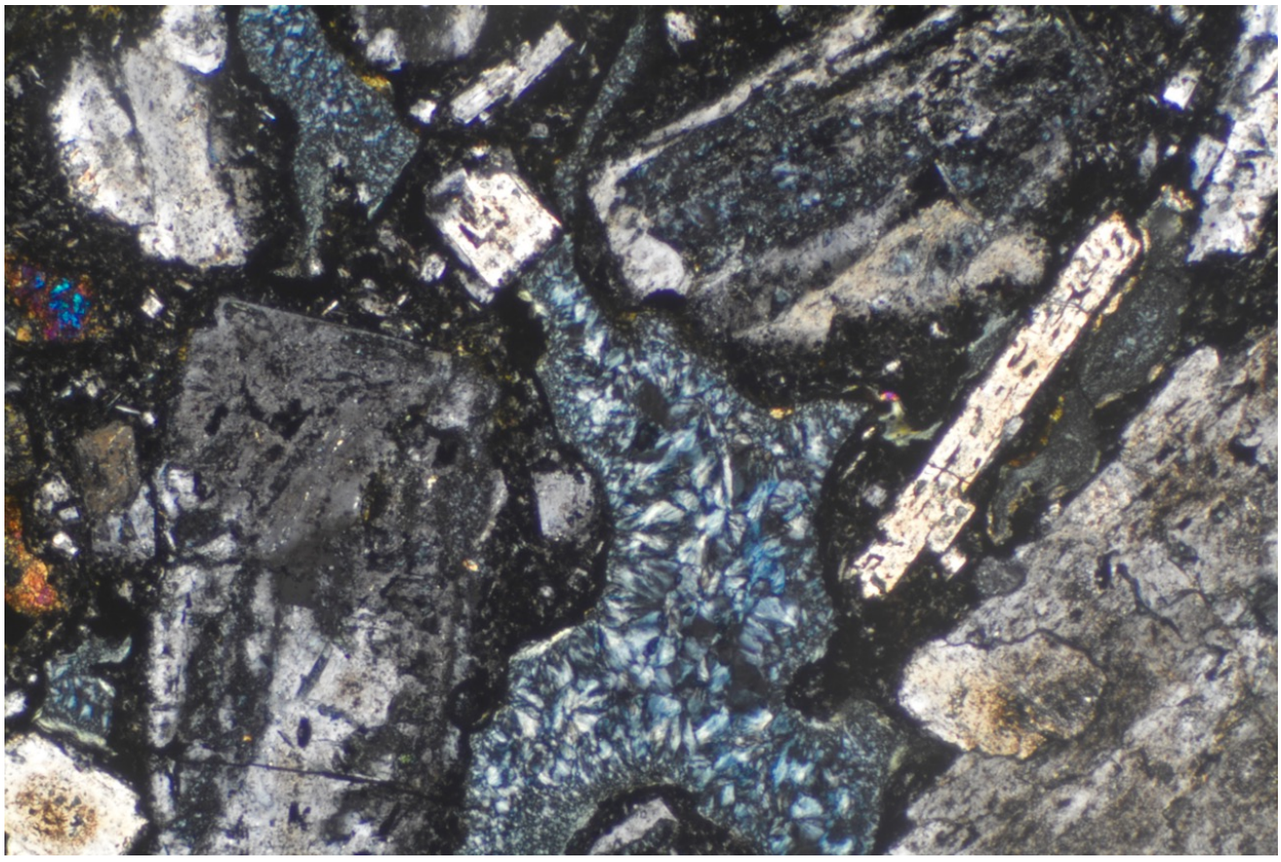
CE416-38.8m – c – a common textural feature showing chlorite patch between several feldspar phenocrysts. Scale: side of photograph is 1.6mm

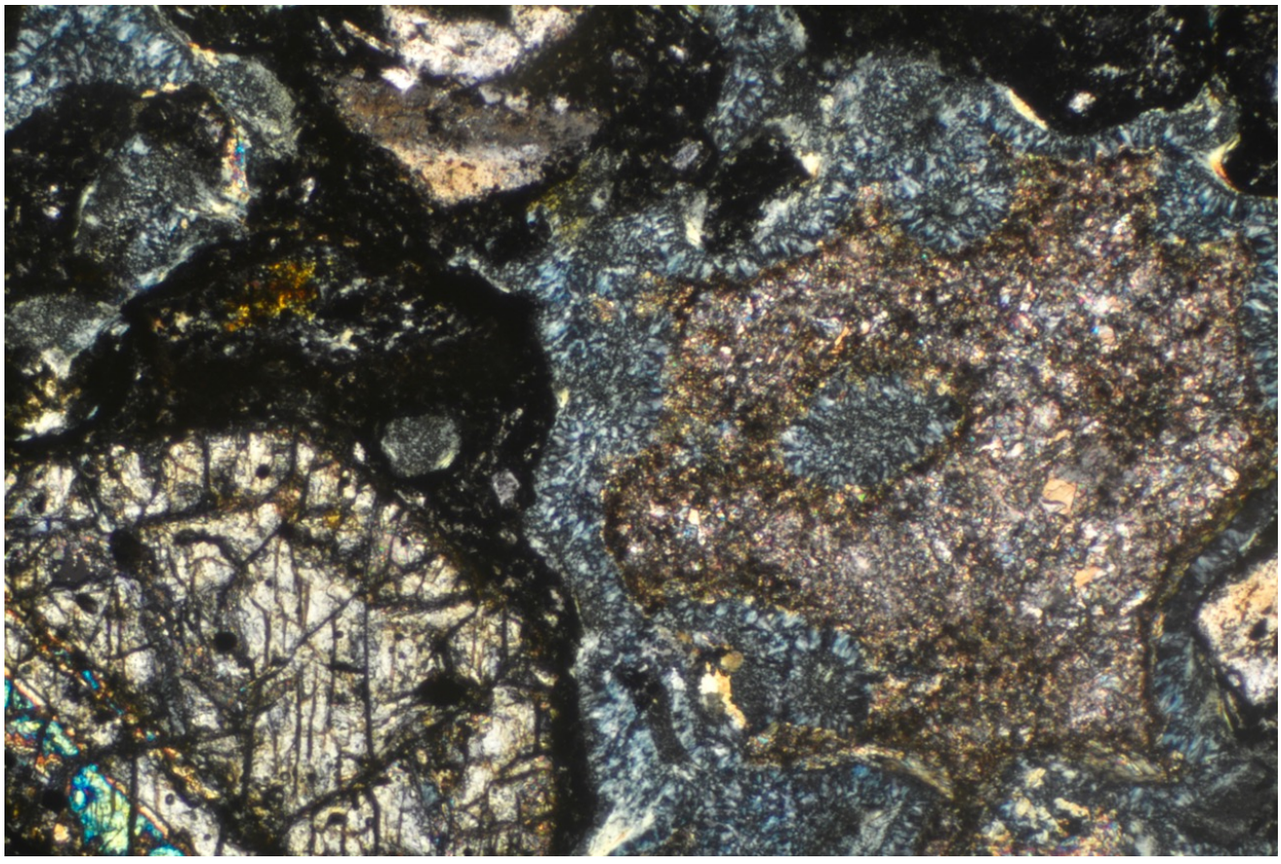
CE416-38.8m – d – a prismatic calcic pyroxene crystals adjacent to a blob of chlorite that is encasing carbonate. Scale: side of photograph is 1.6mm

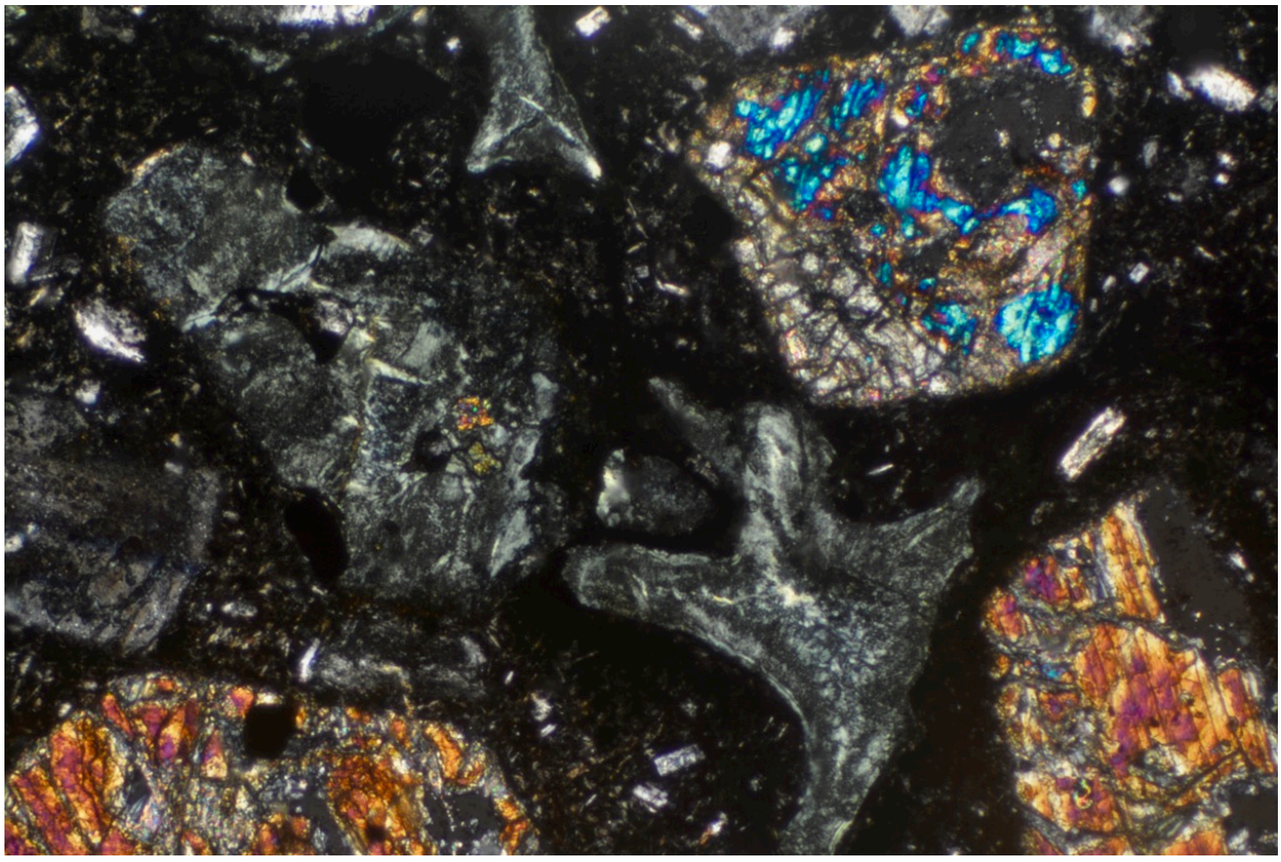
CE416-38.8m – e – a view of chlorite occupying the space between several pyroxene phenocrysts. Scale: side of photograph is 1.6mm

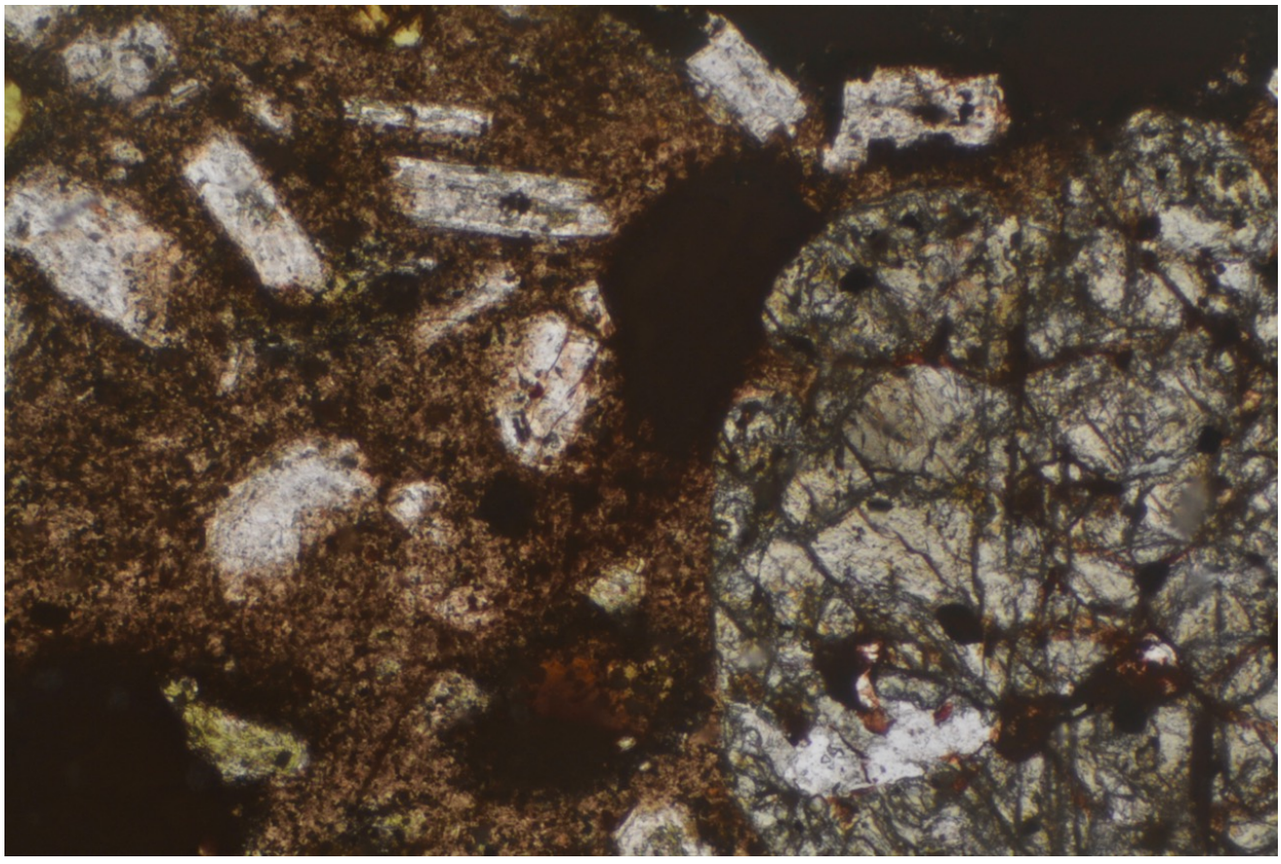
CE416-38.8m – f – view of a pyroxene crystal set in a reddish groundmass. Scale: side of photograph is 1.6mm

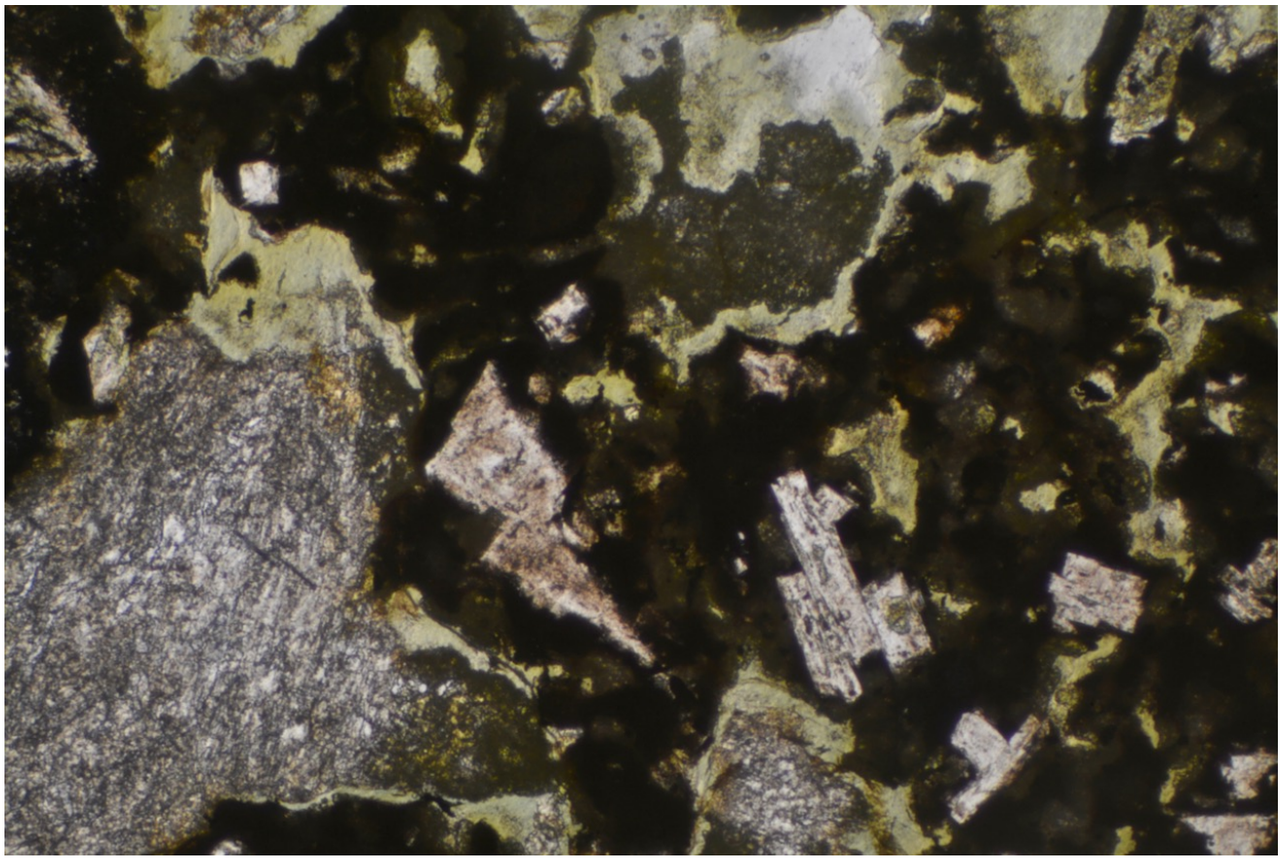
CE416-38.8m – g – view of highly irregular groundmass fragments in a sea of chlorite. The clear crystal aggregate on the left is prehnite. Scale: side of photograph is 1.6mm

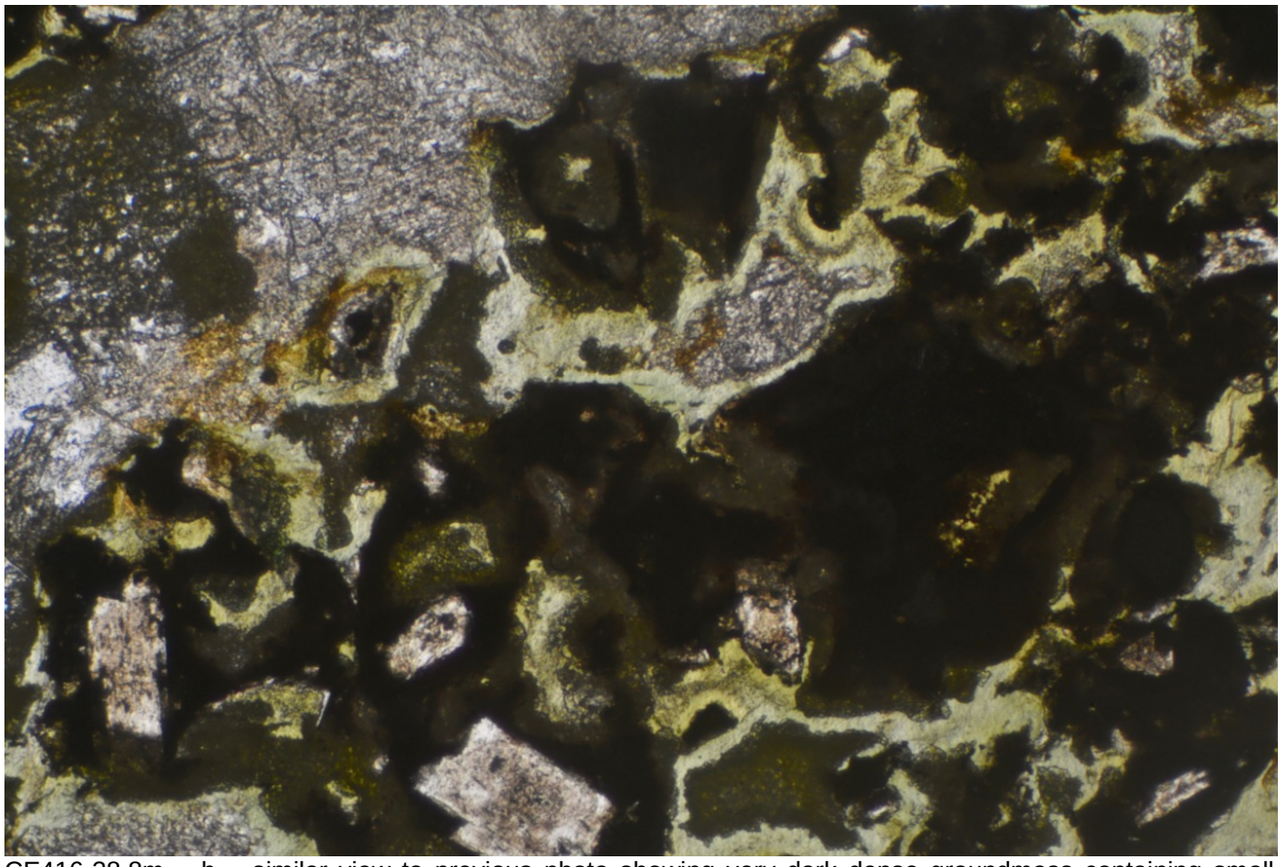
CE416-38.8m – h – similar view to previous photo showing very dark dense groundmass containing small feldspar phenocrysts. Scale: side of photograph is 1.6mm

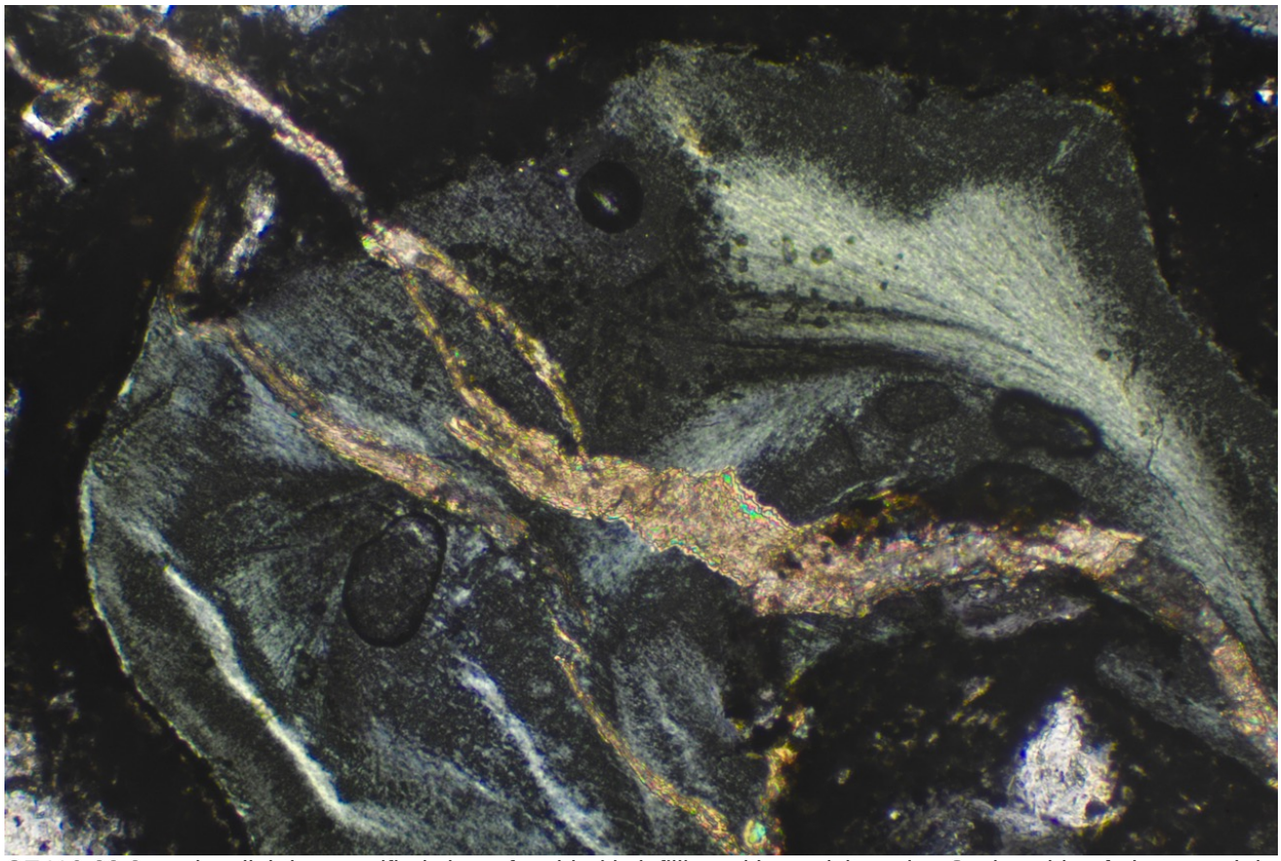
CE416-38.8m – i – slightly magnified view of a chloritic infilling with a calcite vein. Scale: side of photograph is 0.8mm

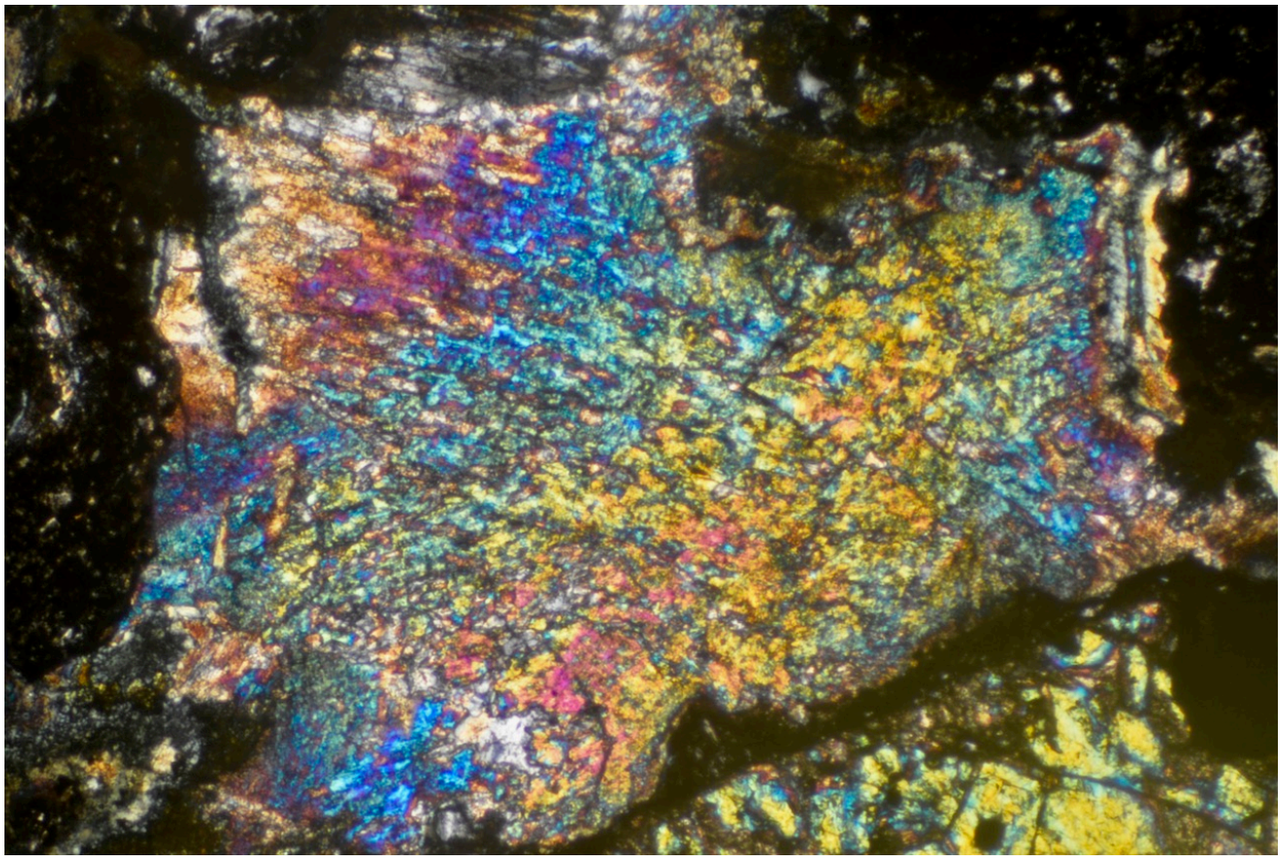
CE416-38.8m – j – patch of prehnite adjacent to a calcic pyroxene phenocryst. Scale: side of photograph is 1.6mm

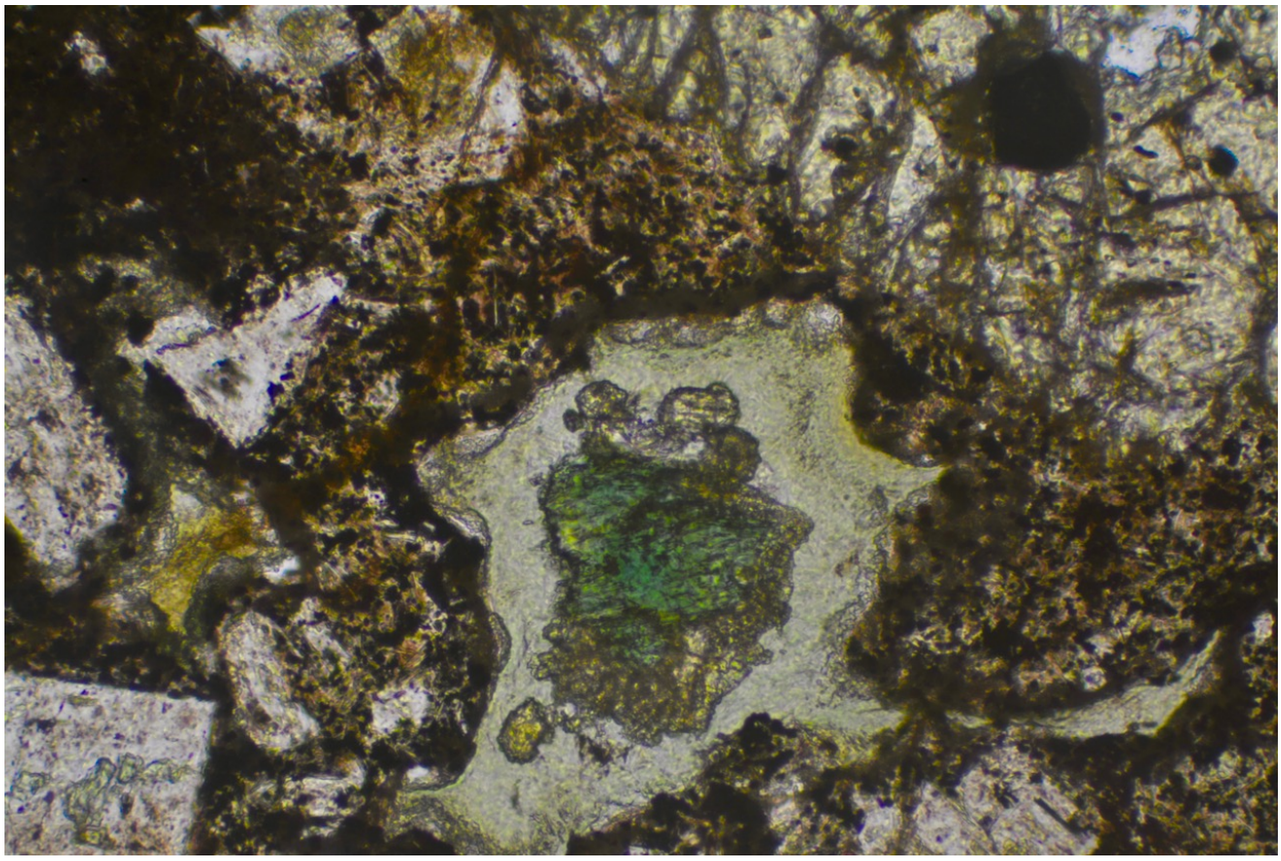
CE416-38.8m – k – an oddity – a brightly coloured crystal of prehnite surrounded by epidote and chlorite. Scale: side of photograph is 0.8mm

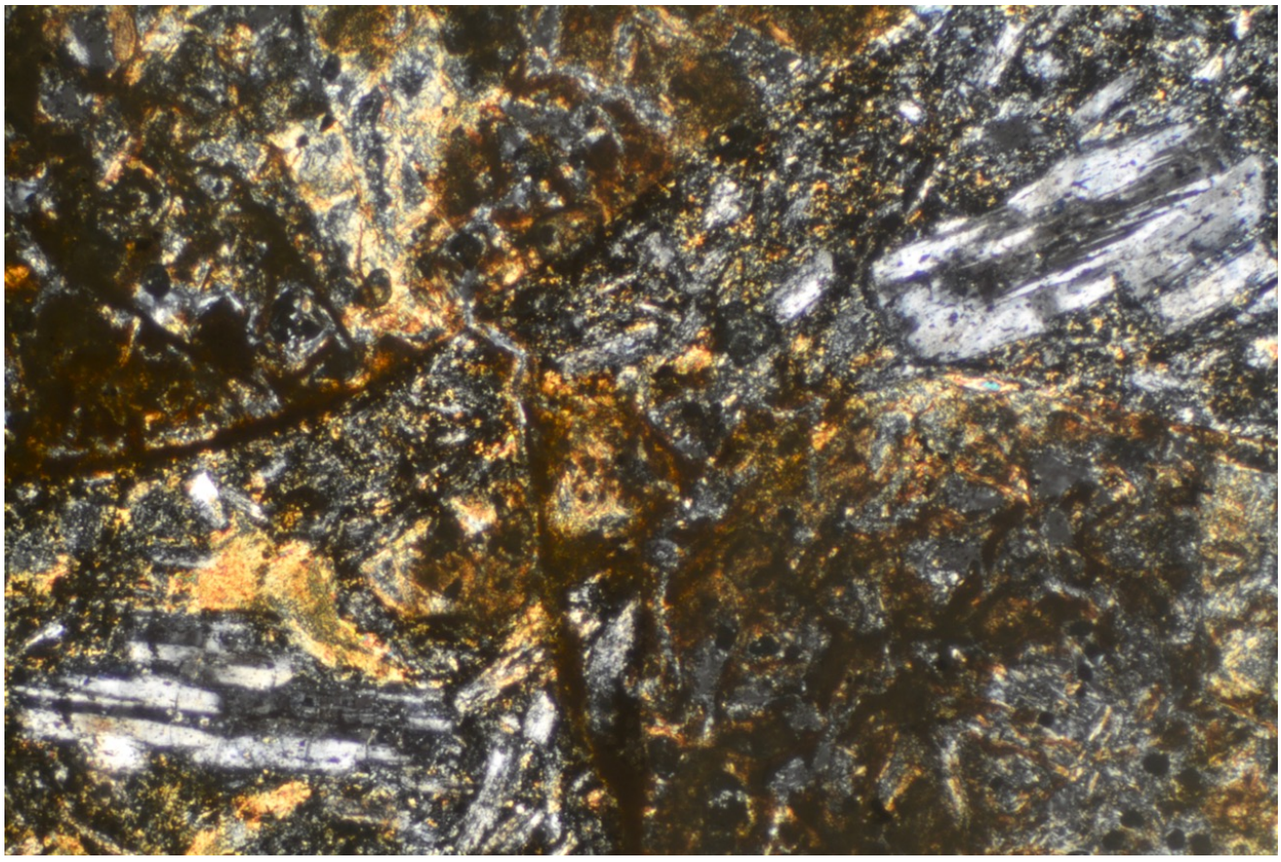
CE430-44.0m a - a common textural view in polarized light of this volcanic rock showing several plagioclase feldspar crystals in a rough alignment. Scale: side of photograph is 1.6mm

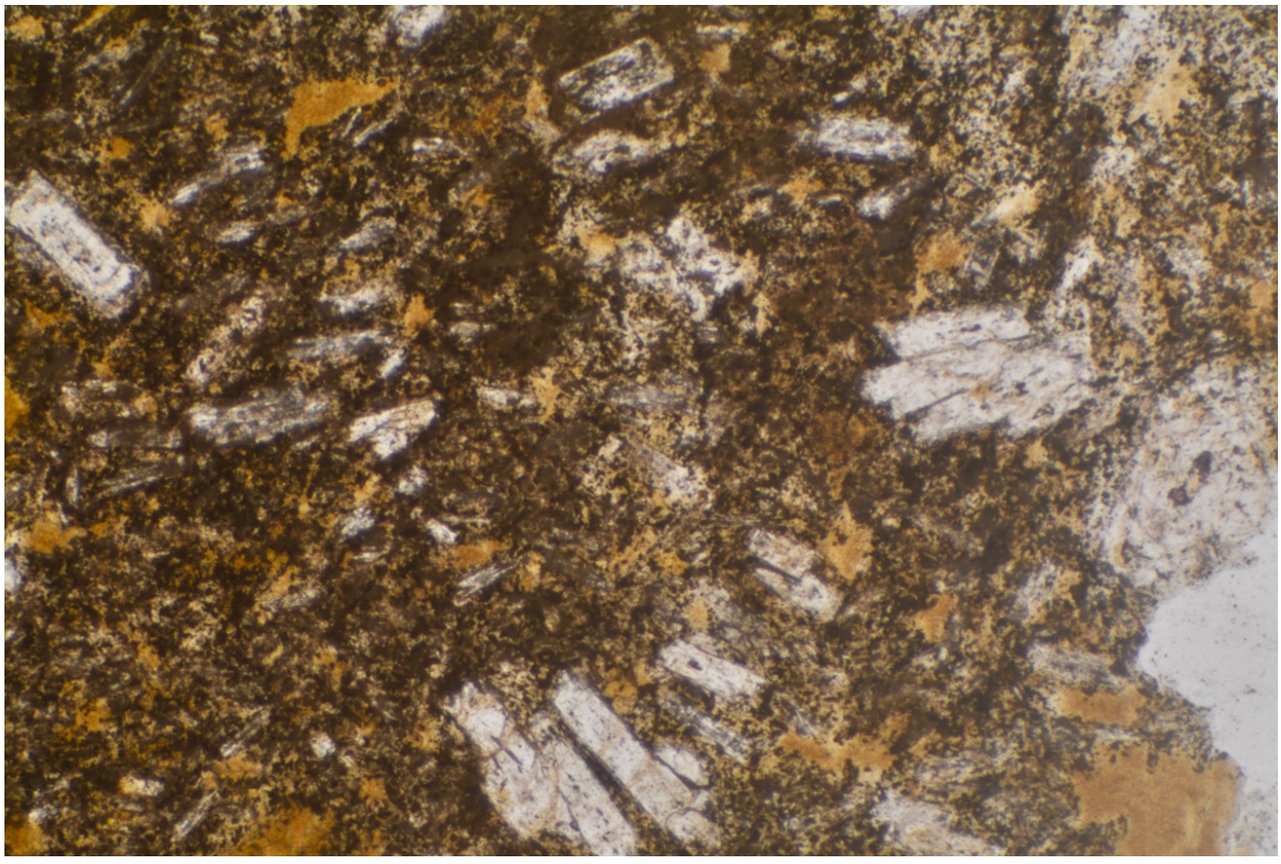
CE430-44.0m – b – another textural view in ordinary transmitted light to show the size and distribution of the feldspar. Scale: side of photograph is 1.6mm

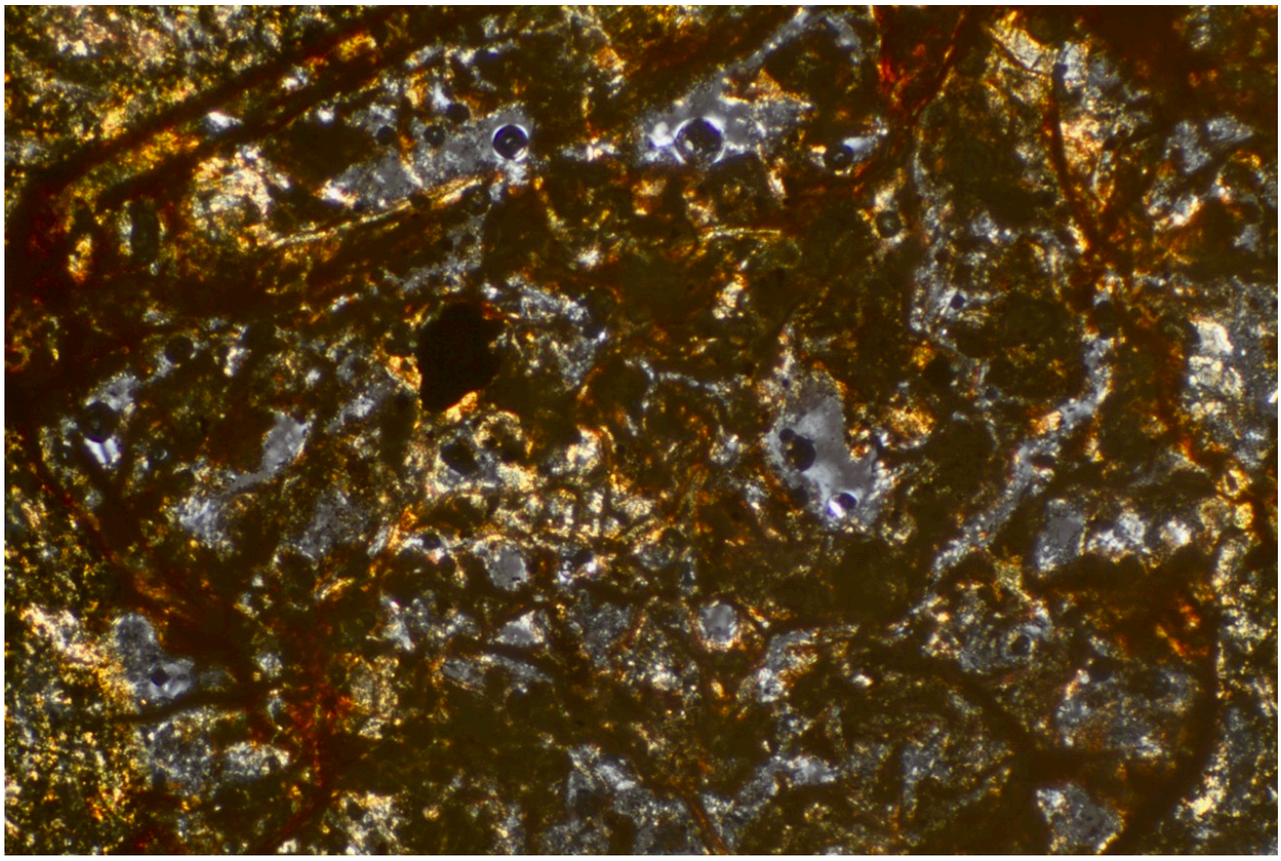
CE430-44.0m – c – portion of a large pyroxene phenocryst that has been totally altered. Note the prismatic shape (top left corner). Scale: side of photograph is 1.6mm

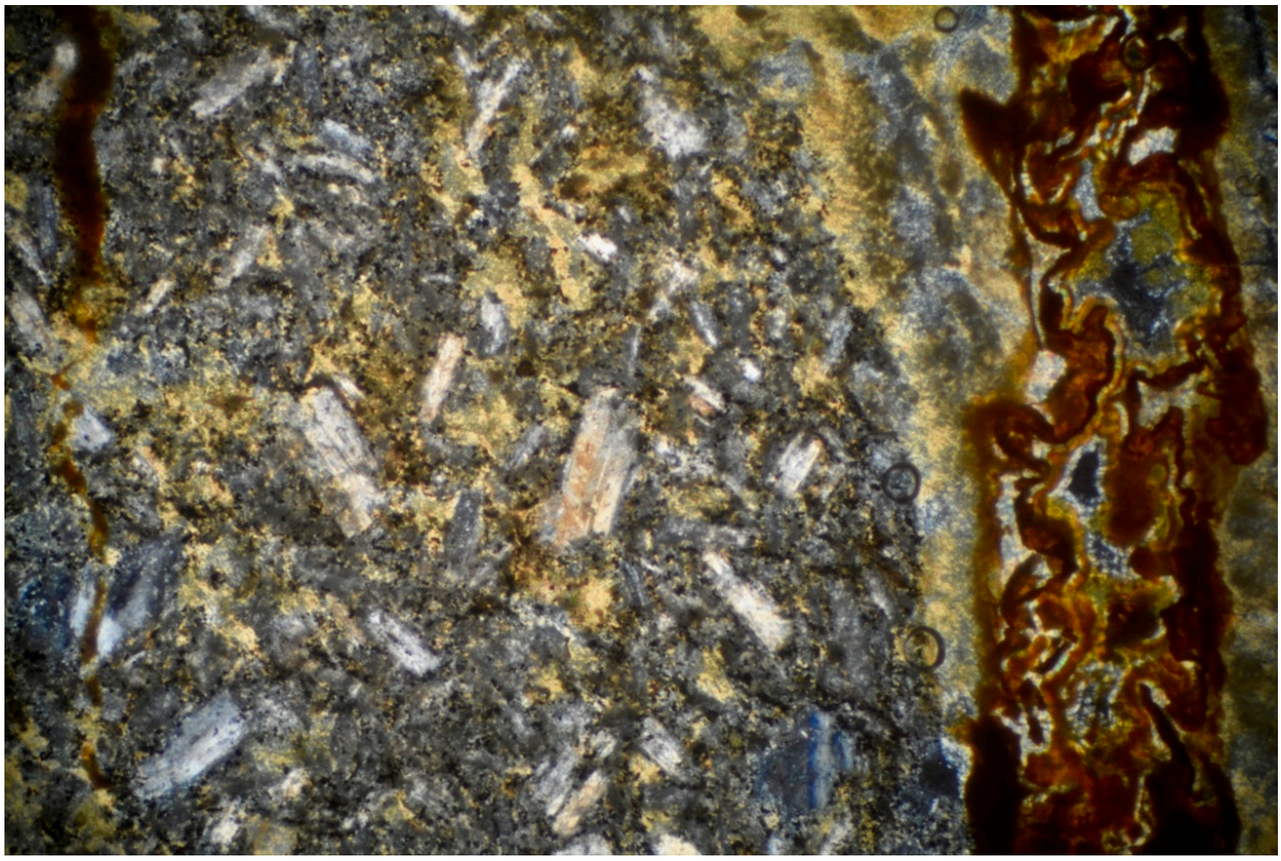
CE430-44.0m – e – a condenser-enhanced view of the texture in the most unaltered area. Scale: side of photograph is 1.6mm

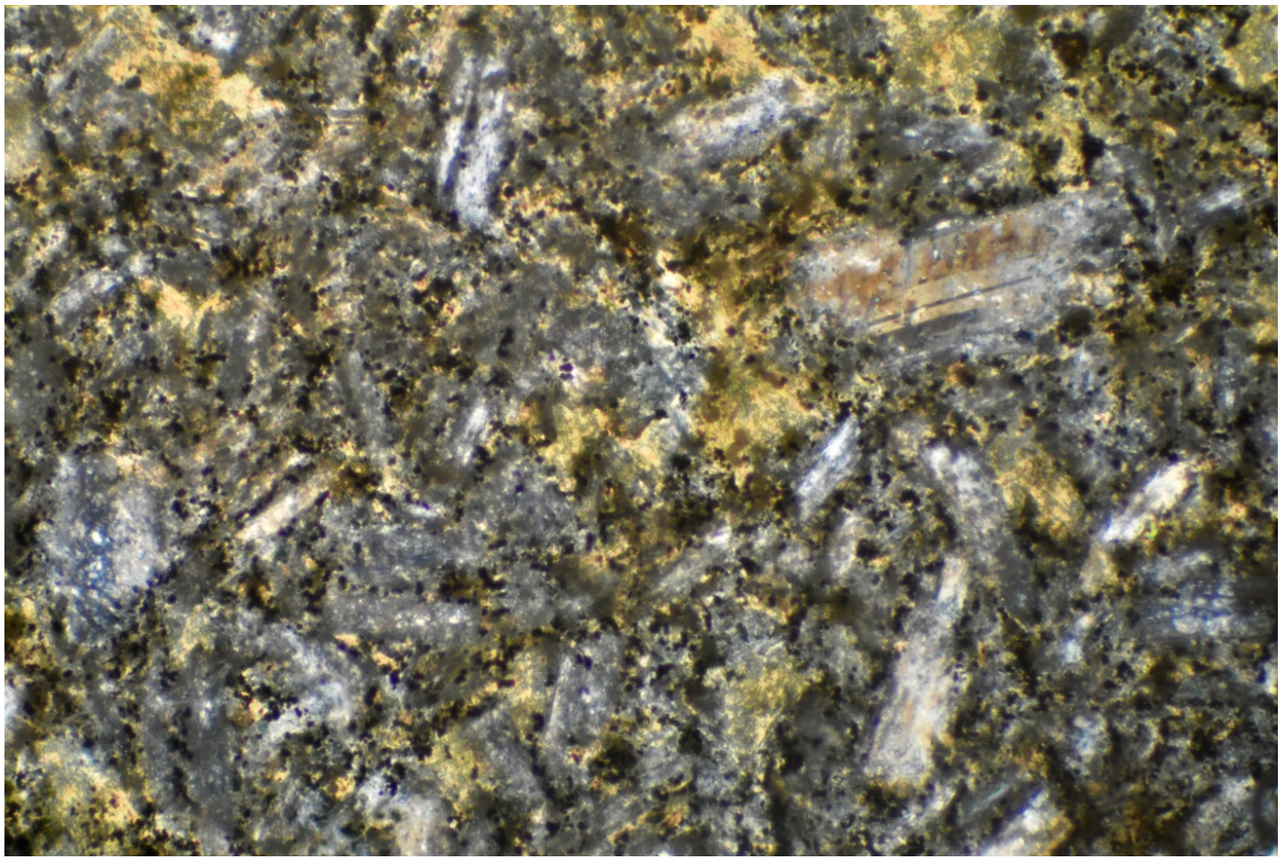
CE430-44.0m – f – a slightly magnified, condenser-enhanced view of the groundmass showing some twinning in the feldspar. Scale: side of photograph is 0.8mm

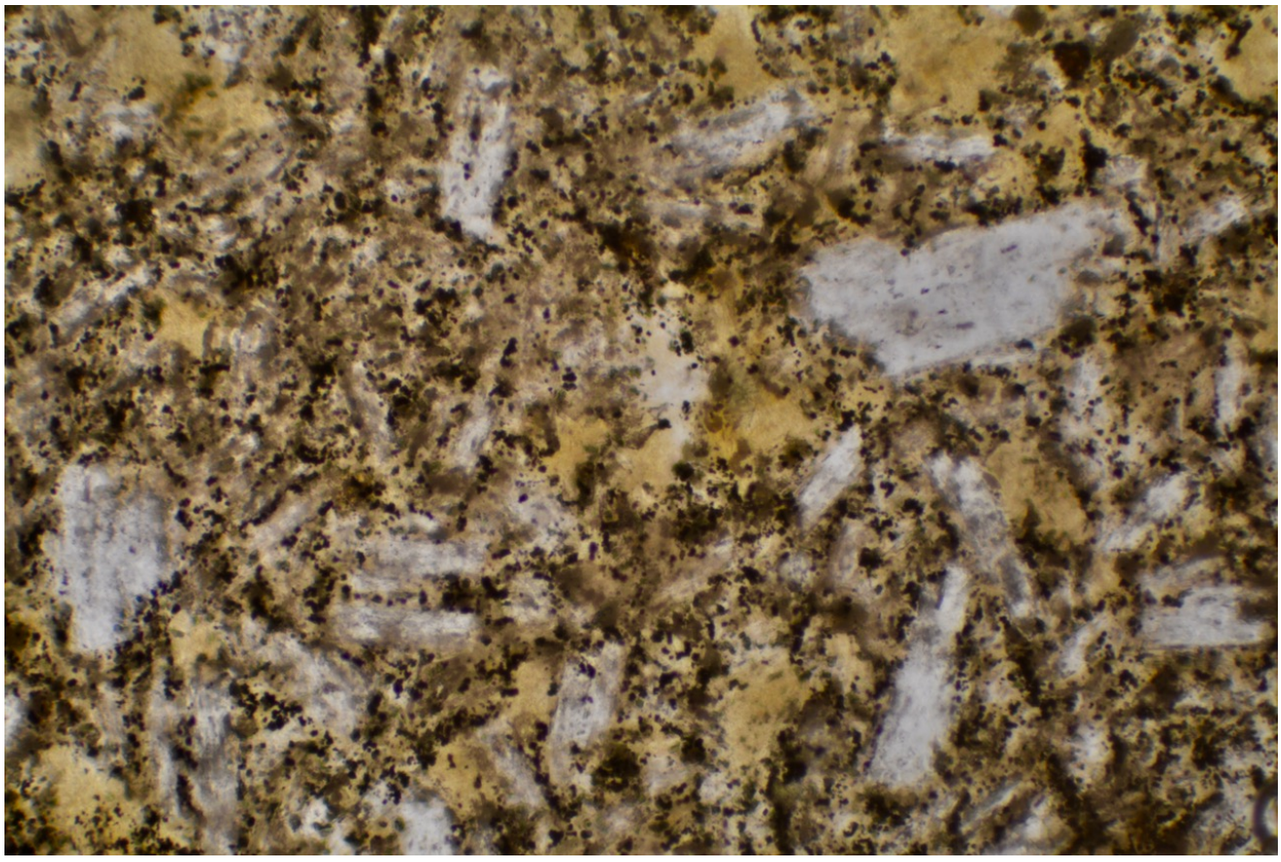
CE430-44.0m – g – same view as previous photo in condenser-enhanced light showing the patchy alteration to clays and the abundance of tiny encrustations of hydrated iron oxide. Scale: side of photograph is 0.8mm
